## A beginners guide to Burman II – by Joe Rayner

### Part 2

#### Burman Gearbox Wear and Tear

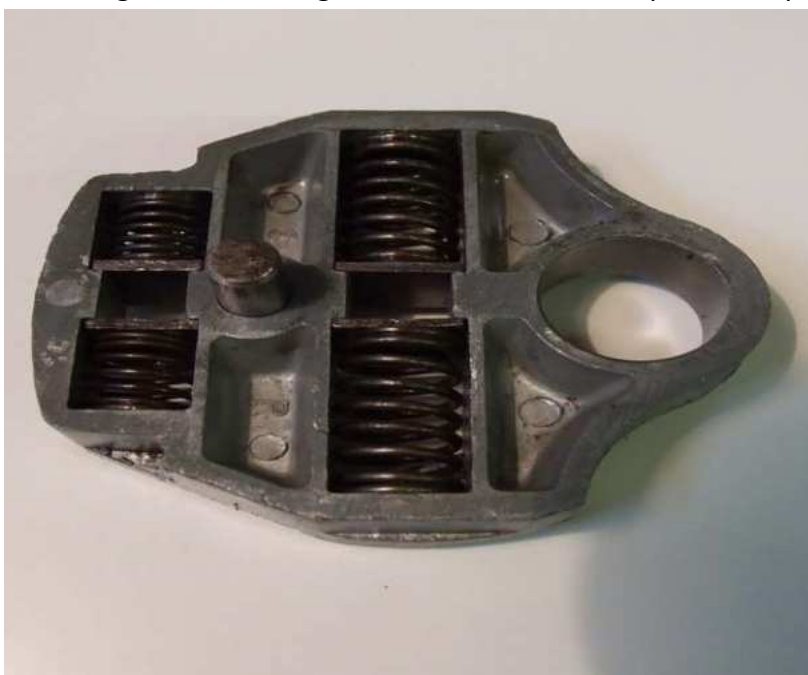
The alloy spring box needs close inspection for cracks & damage, and the steel pin needs to be secure. The springs can wear 'flats' on their outer edges which may bring about failure – with the gear lever failing to return to the normal position. Spares are available.

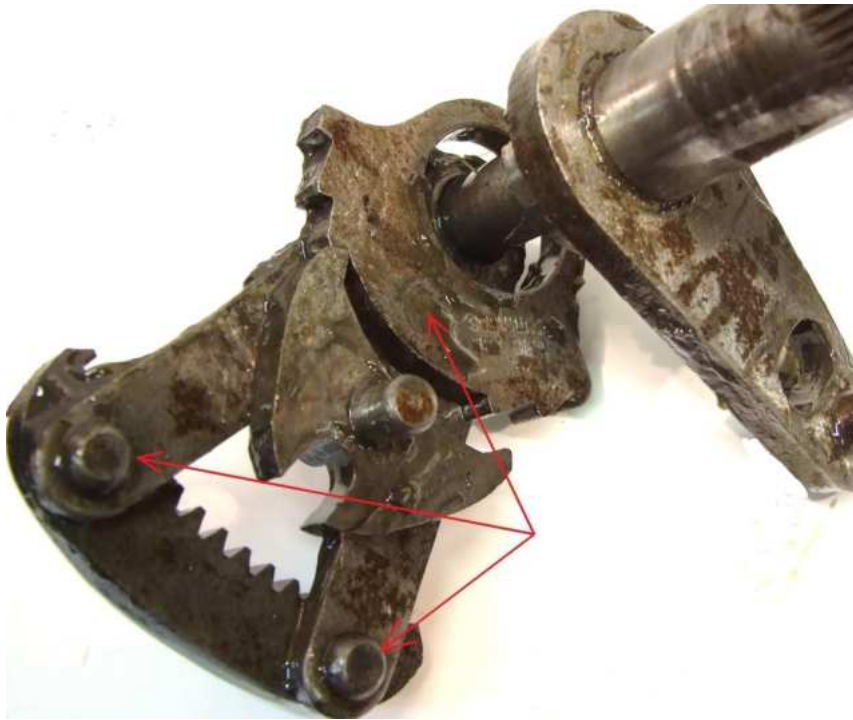
The selector pawl assembly is riveted and the 3 rivets needs to be secure – if you need to tighten yours make sure that the shaft is in place to keep everything centred on the single rivet, otherwise you risk making it very secure , but in the wrong position.

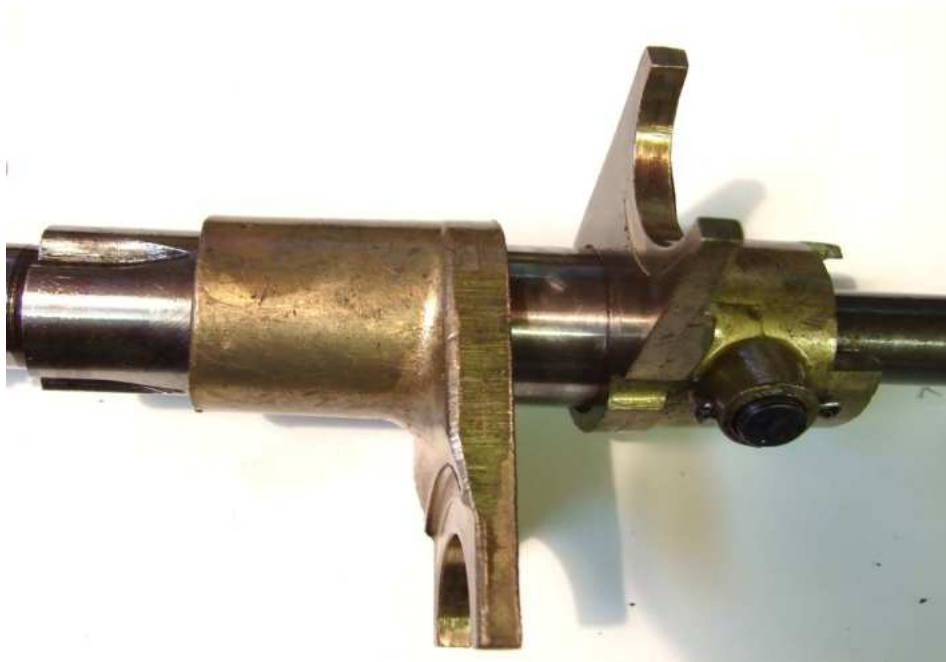
The selectors within the gearbox can become bent or worn and there's not much that can be done by way of repair, so better replacements will need to be found. This looks like a replacement as it's in good condition. There is no great need to dismantle this assembly if the selectors are serviceable.

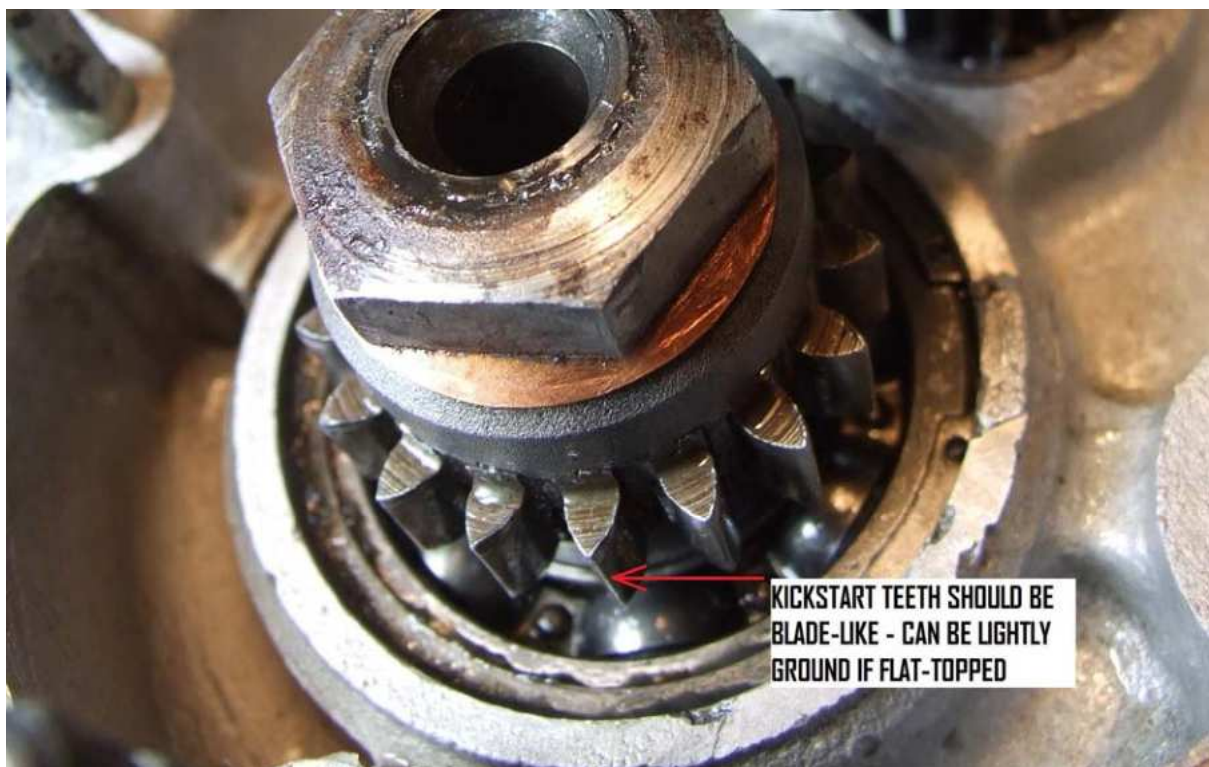
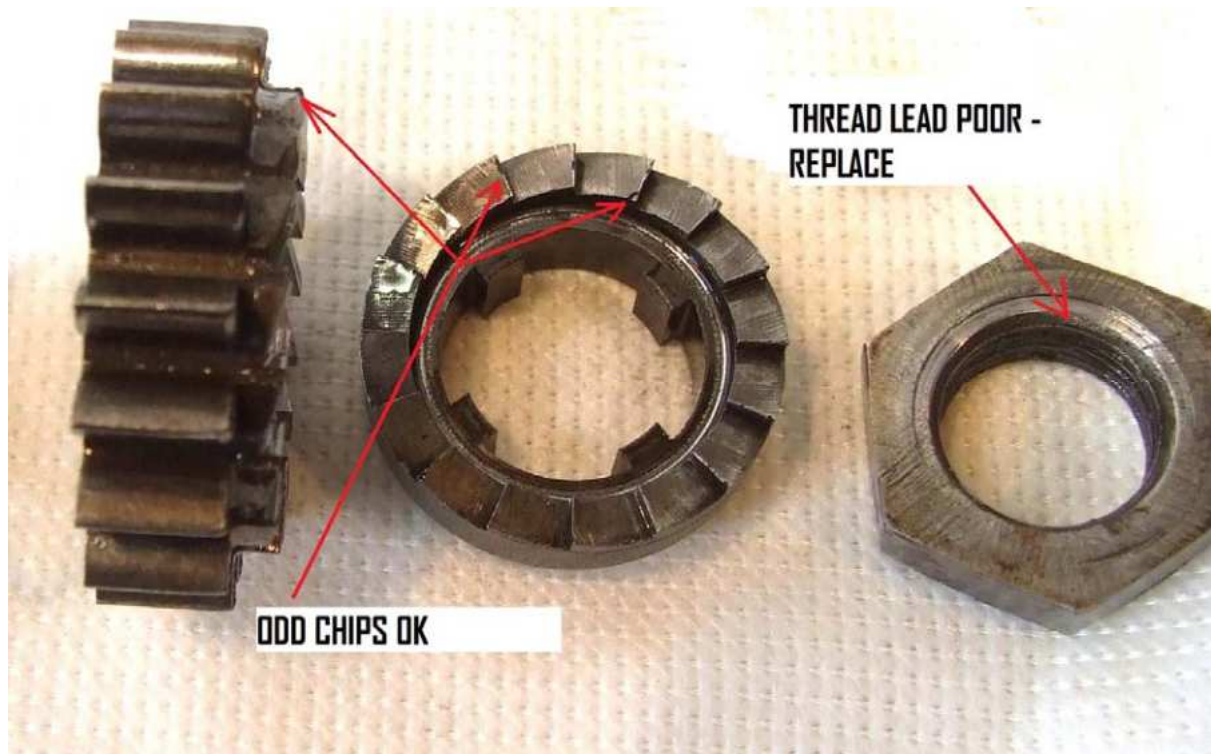
If the kickstart ratchet is prone to sticking – a 'solid' pedal as you push down – it may be caused by the ratchet teeth flattening off at their tips. If not too bad they can be carefully sharpened, but new available from POC. The same symptom can be caused by a sticking clutch, so free/adjust the clutch before thinking about taking the gearbox apart.

If in poor condition the above assembly is available new from POC, and the spring dimensions when new are 19mm L x 27.5mm O/D.

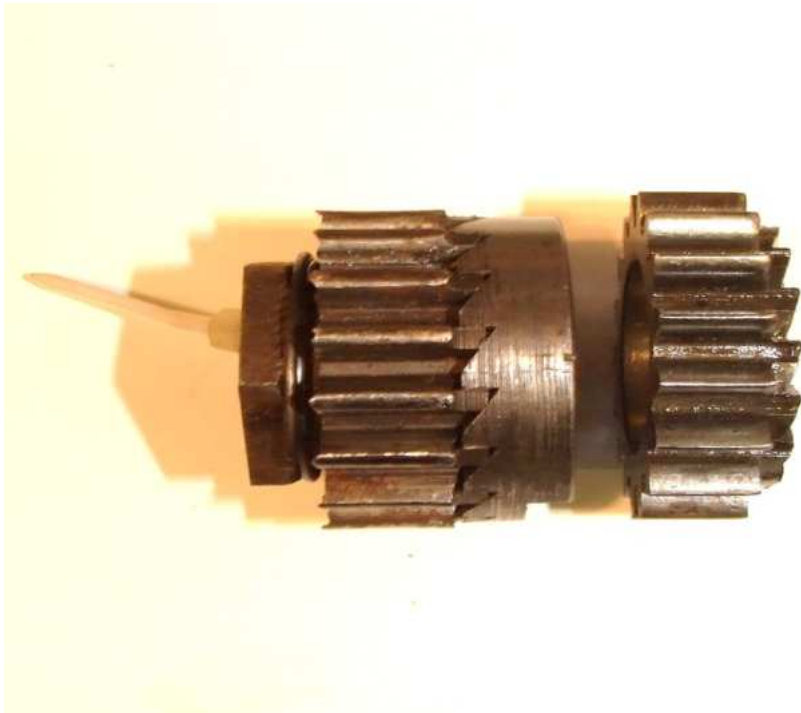
Shown, left, a very worn kickstart, compared with a used, serviceable one.

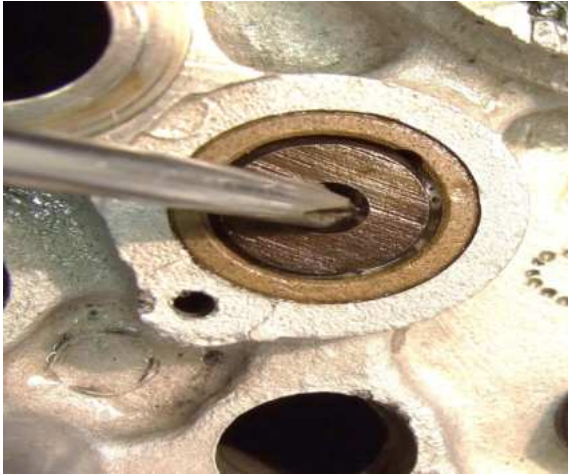
Look at the end of the layshaft when in situ and push it sideways with a screwdriver – you'll hear the oil 'click' as it gets pushed out of a worn bearing. New bushes are readily available

from POC and bearing suppliers, but need shortening by 2mm, an easy enough job. Once out of the heated cases the old bearing dimensions will change, and new bushes must go back into heated cases. It is false economy not to change the bushes, even if you need professional help with the reaming – reamers are now very cheap and it's a straightforward job to do it yourself. Note 'trough' machined in bore at 2 O'clock position. New bearings don't have these - you'll be cutting this too, after reaming.

If you intend to ream your own bushes and haven't used a reamer before, then practice on your old bushes whilst they're still in the cases. More detail on doing this later.

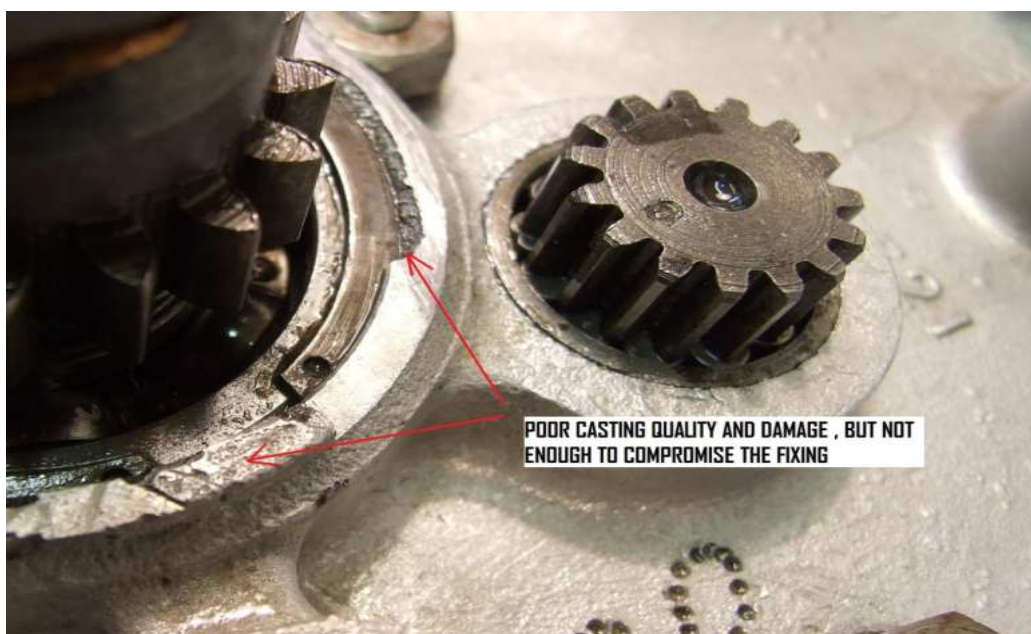
Mainshaft outer bearing housing, in the 'middle' layer of the gearbox needs inspection – check for bearing 'spinning' in housing & general damage , on both the bore and the thin walled casting beneath the bearing. This bearing had been incorrectly assembled, with the steel spacer placed below the bearing, not above, directly under the circlip, as it should be.

This allowed extra backlash in the mainshaft, affecting the clutch and gearchange.

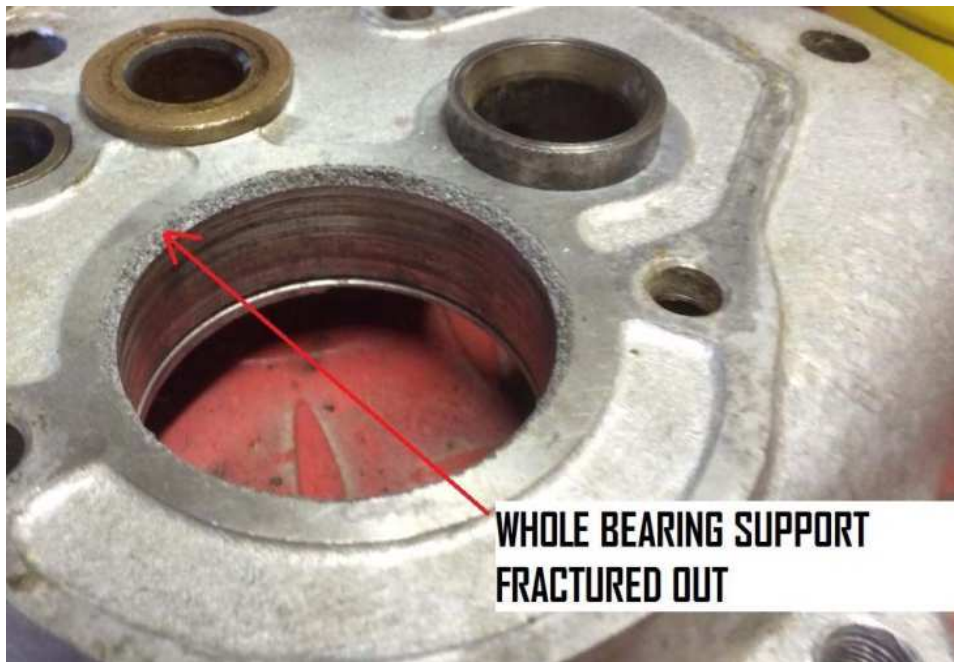
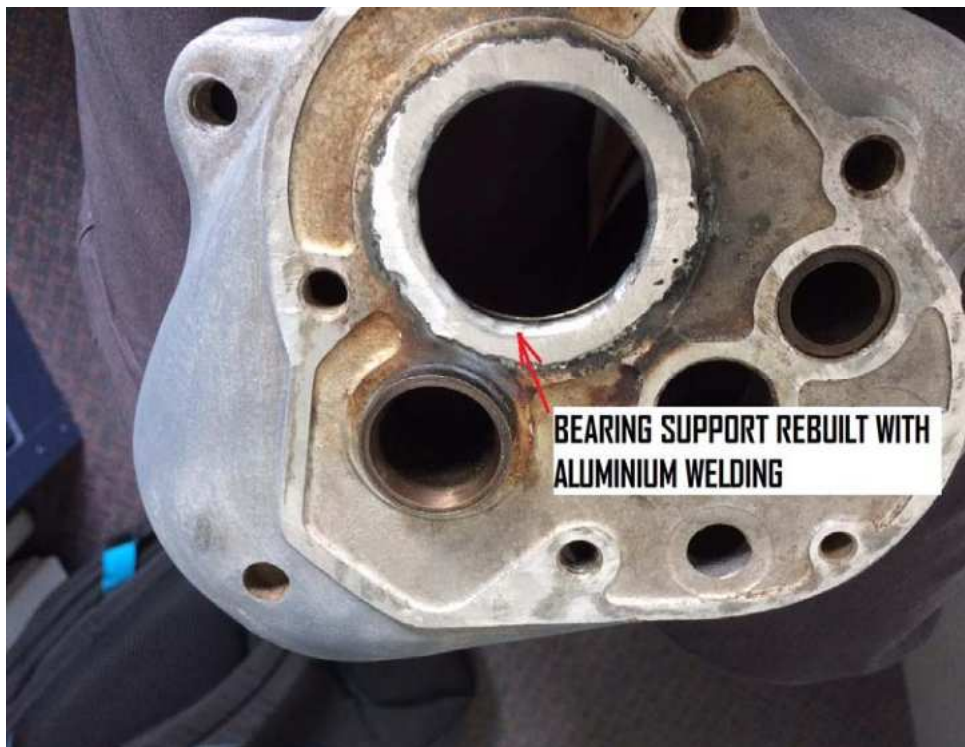
The next one needed a lot of thought! This was the back of the middle casing, outer mainshaft bearing housing . It's not there! Possible causes may have been the bearing being pressed into place without supporting the back of the casting, or levering the clutch hub off of its splines. It needed professional expertise.

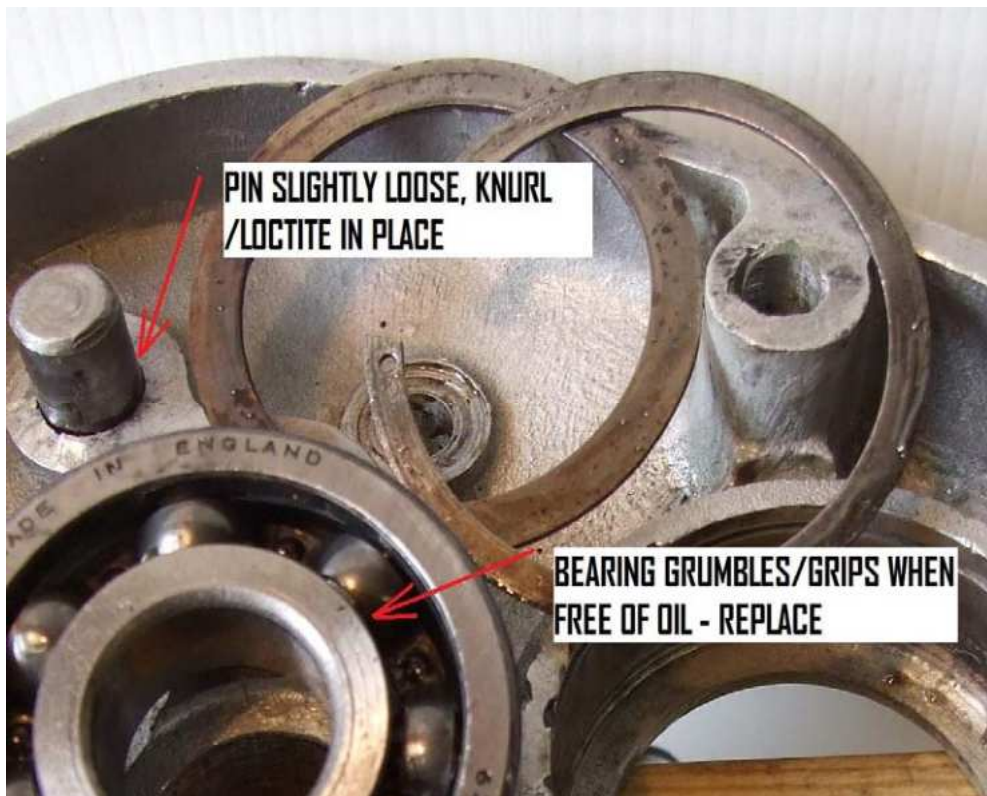
As with any accessible bearings, if in doubt, replace. This outer main bearing, relatively new, initially felt OK, but a wash out with a squirt of carb cleaner revealed that it didn't spin smoothly, and a judder could be felt as it slowed, so maybe some pitting. Available from POC and is a standard metric bearing, SKF 6304, held by all bearing suppliers and widely used on agricultural equipment, as are new circlips.

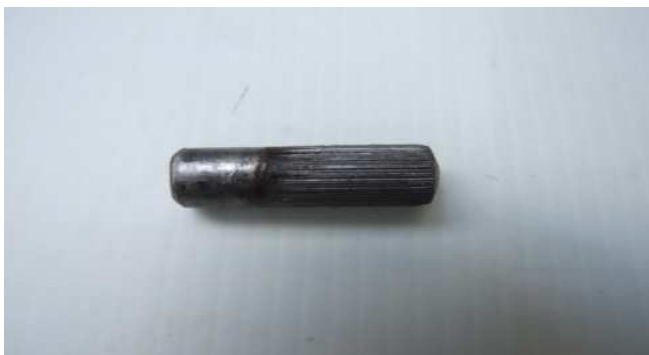
The kickstart stop pin takes a battering and should have a rubber buffer fitted. Without it the kickstart, if released suddenly (or a Panther kickback) hammers the pin and casing. The hole becomes eccentric and the pin can bend too. The pin can be knurled if you have access to a lathe, or a slightly larger pin made, and Loctite can help to secure a slightly loose pin. Fractures may radiate out from the pin hole, but probably not far, so welding may not be necessary. Fit a buffer from the POC or make up one from a short piece of reinforced high pressure fuel hose, or nylon if you have access to a lathe.

A knurled pin, ready to fit – note how the pin diameter has 'grown' .

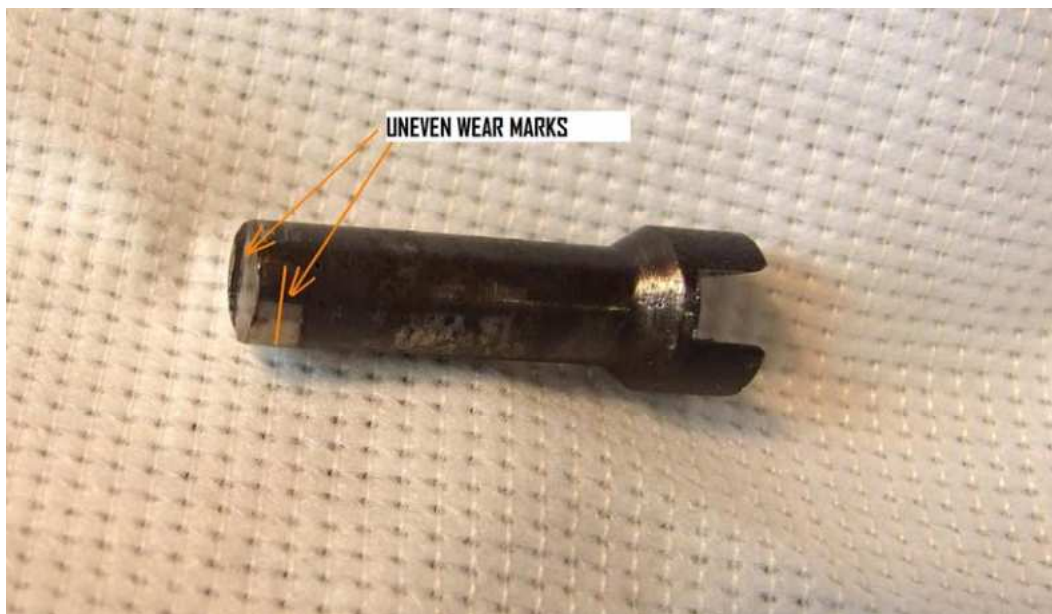
The clutch 'clevis' pin can wear unevenly and is available from POC – you may be able to re-face the end of this one by grinding. In situ it should have a ball or roller bearing between it and the clutch rod.

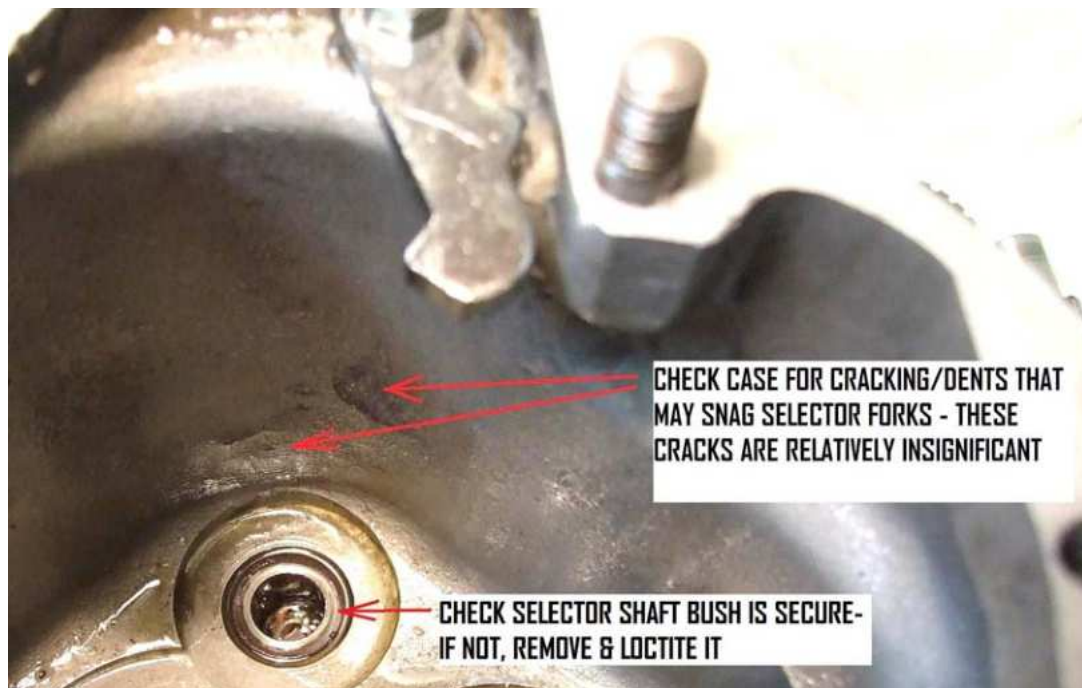
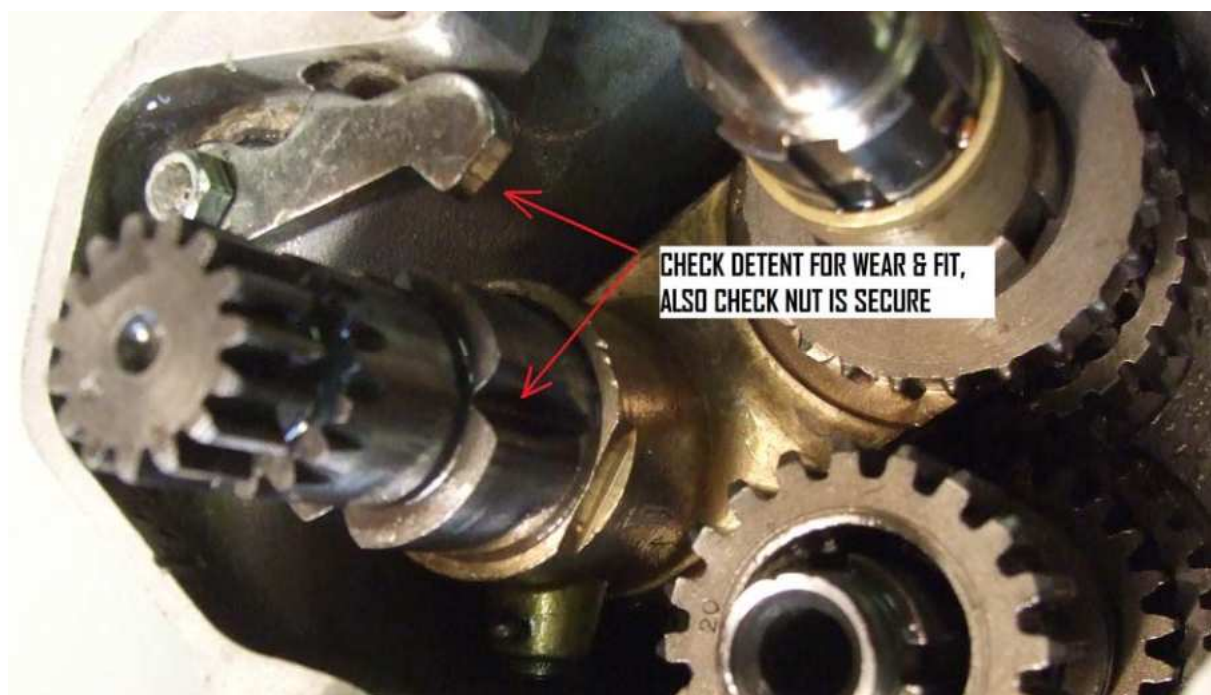
Stud thread damage is possible, along with dents & cracks. The gearbox can collide with the frame member and it pushes a dent into the casing, which, if deep enough, stops or interferes with the gear selector assembly.

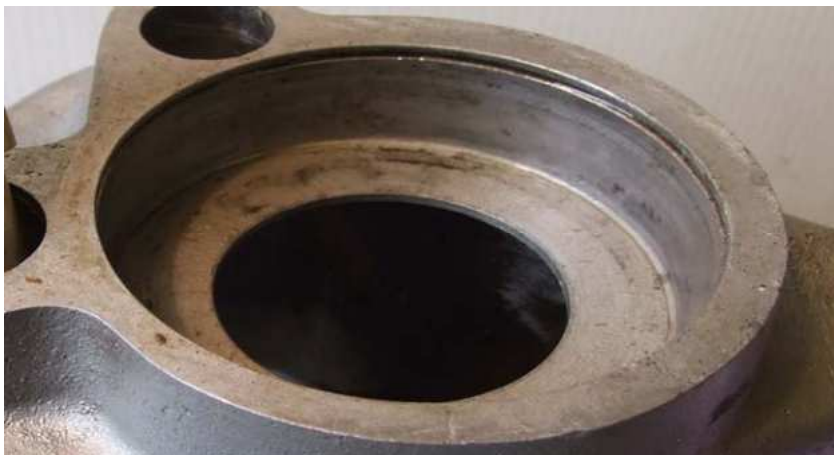
The clutch end large mainshaft bearing may be loose in the casing and have 'spun'. Look for scoring/check for loose bearing in housing. Loctite bearing locker will fix this. This one is good, but the bearing came out very easily, so Loctite Bearing Locker will be used on reassembly.

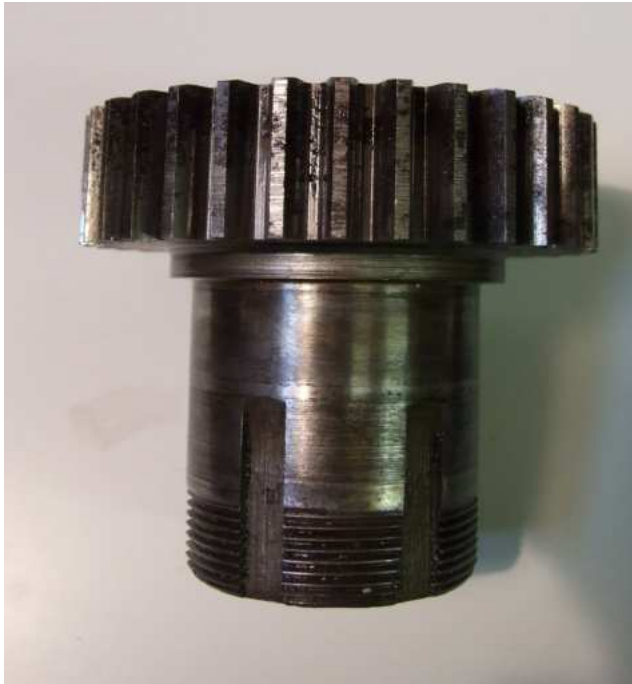
The gears probably all looked as good as new when you opened the oily gearbox, but close inspection probably revealed a few flaws, most of which have relatively little impact on the working of the gearbox, but may add to noise. Some erosion/corrosion on this main gear, but it's going back in, once new bushes have been fitted within, but it may add to the whine!

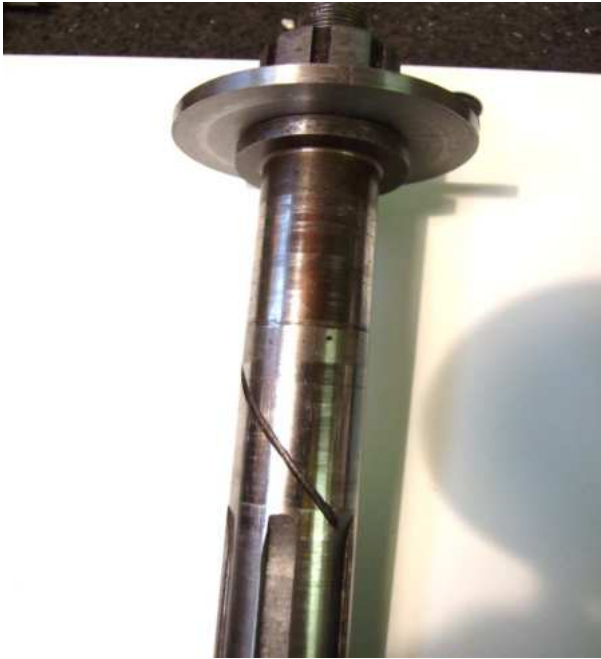
This needs close inspection for thread damage, spline & shaft wear, particularly in relation to the drive gear sleeve, which contains a pair of thin-walled Oilite bushes. The bushes are likely to be worn, but they may have also, to a lesser extent, worn wide grooves in the main shaft.

Unfortunately any replacement bushes can only be reamed to the original shaft diameter, so if there's wear on the shaft, there will always be some play in the finished assembly. It's a matter of judgement – if the shaft has 3 thou of wear, and the old bushes another 12 thou, then with new bushes reamed to original diameter, then you'll end up with 3 thou clearance, so a worthwhile gain from where you started at 15 thou! It is possible to get the mainshaft chrome plated and ground back to standard, or new ones are available from the POC. This shaft clearly has a pair of worn bands that match with the Oilite bushes of the main gear, but not so awful that it can't be put back into use, especially as the clutch splines are good.

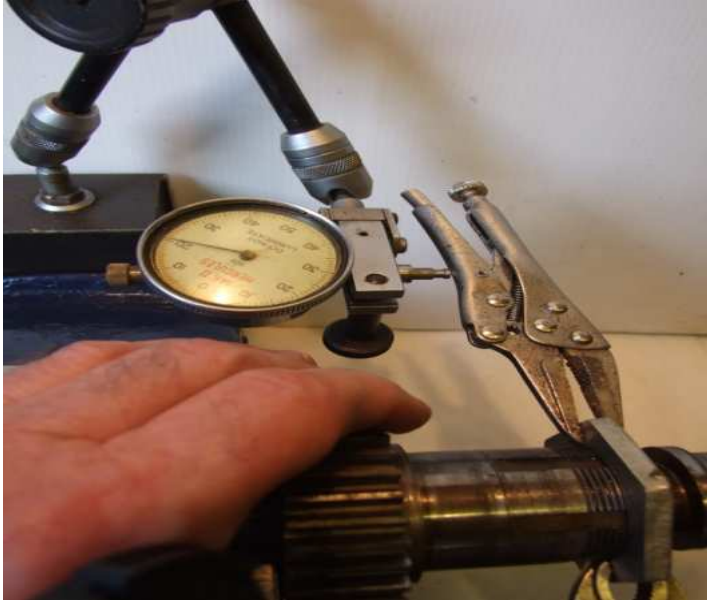
Rock the drive gear on its bearing and the movement will be similar to the rock that is found at the clutch sprocket teeth. I set up a dial gauge, and, on a 'moderately' worn bearing/shaft, there was 20 thou+ movement at the same diameter as the clutch –

which is a 40 thou rock when you wriggle the clutch in situ. Doesn't sound a lot, but feels it!

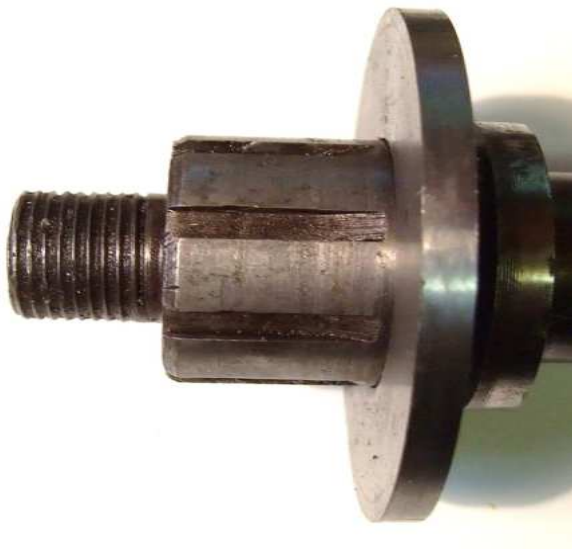
The clutch end of the mainshaft is splined to accept the clutch hub and all of the engine power passes through those slots. It's no surprise that they become distorted/worn, and damage here may tip the balance towards a new shaft. A damaged one can be welded and re-cut, but at £60 a POC one could be a cheaper option, especially if you have both shaft wear & thread damage.

Later POC clutch centres have deeper splines which engage with almost the whole of the mainshaft grooves, and damage therefore avoided. These slots are pretty good.

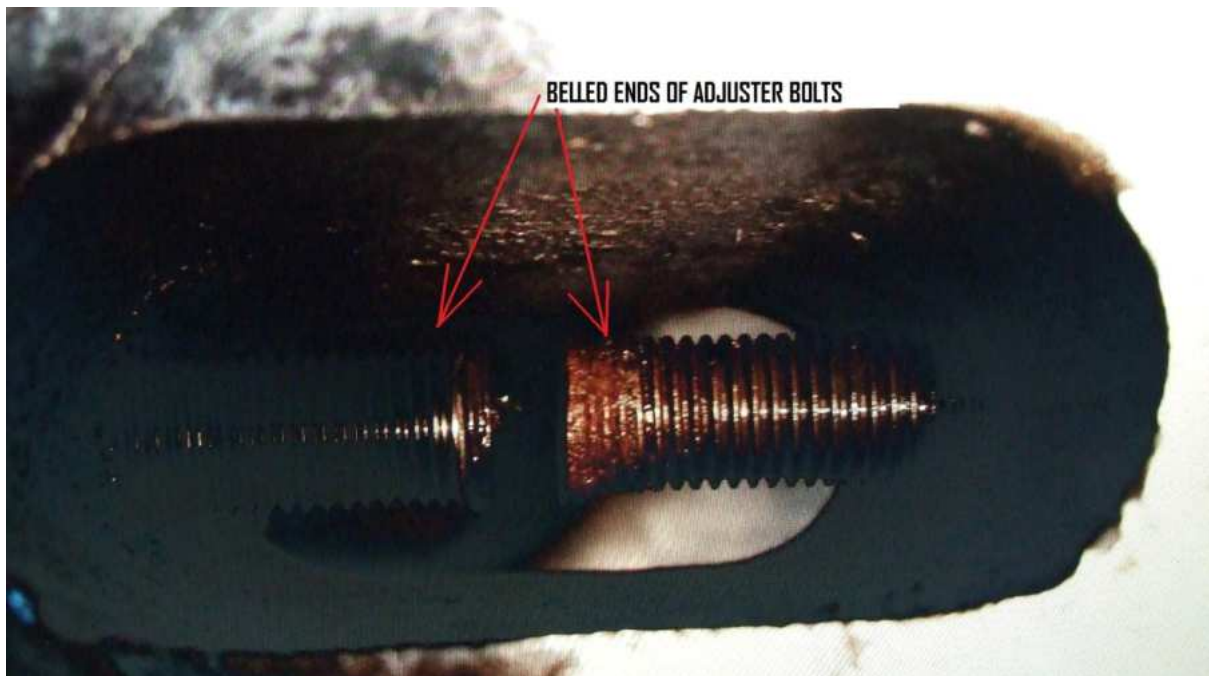
At the bottom of the gearbox there are 2 adjuster bolts that thread through the gearbox mount and these may have stripped the casing thread, or be impossible to remove. There are a number of ways to deal with this problem and they are described at the end of this section . Don't attempt removal if like this – you will destroy possibly good casing threads!

The BSF threads on the adjuster bolts shown here are in good condition, but any attempt to remove them from the casting will strip the alloy of its threads, and the bolt will still be stuck. Choices are to attempt to file the ends off of the bolts or to wind them out with your fingers until they bind. With a lock nut left on the thread, saw the bolt off a couple of mm short of the lock nut. Cut a hacksaw slot in the short stump of the bolt and wind off the lock nut. This will tidy the cut end of the bolt, preventing damage to the alloy casting.

Use a screwdriver to wind the bolt back in through the casting and it will fall off inside, allowing you to replace it with new.

If the thread has stripped then either drill the hole out and tap to a larger size, or have a thread insert fitted and keep the original BSF size. Both will do the same job.

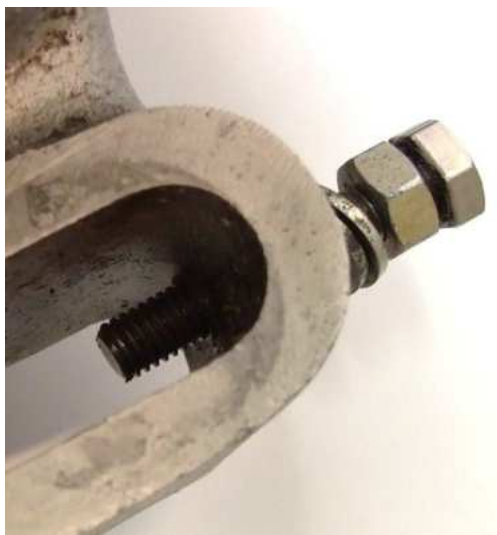
Shown is a replacement Helicoiled bolt – it's worth chamfering the bolt end a little, to allow for future mushrooming of the end.
