## A beginners guide to Burman II – by Joe Rayner

### Part 2

#### Burman Gearbox Wear and Tear

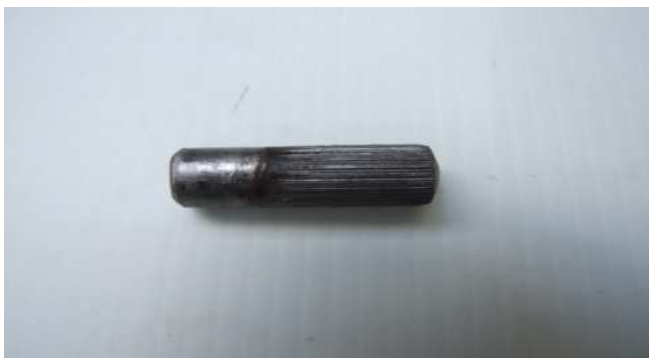
A knurled pin, ready to fit – note how the pin diameter has 'grown' .

The kickstart stop pin takes a battering and should have a rubber buffer fitted. Without it the kickstart, if released suddenly (or a Panther kickback) hammers the pin and casing. The hole becomes eccentric and the pin can bend too. The pin can be knurled if you have access to a lathe, or a slightly larger pin made, and Loctite can help to secure a slightly loose pin. Fractures may radiate out from the pin hole, but probably not far, so welding may not be necessary. Fit a buffer from the POC or make up one from a short piece of reinforced high pressure fuel hose, or nylon if you have access to a lathe.
