# 1937 Sunbeam Model 9 Engine Overhaul

**Thomas Eversberg**

**Joe Rayner**

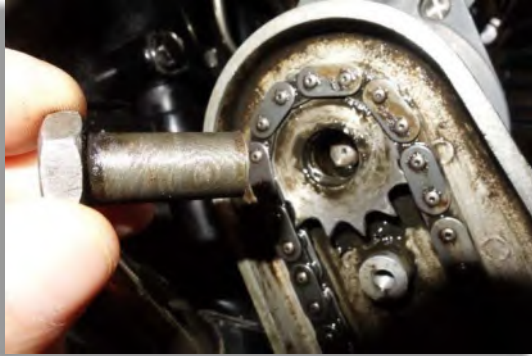
*Figure 1: The upper sprocket pulled off the magneto taper.*

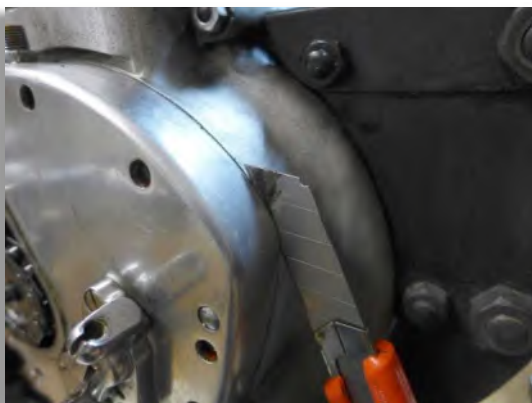
*Figure 2: Opening the timing cover. To avoid damage, one should not apply force but the careful use of a cutter blade and a hammer.*

The timing cover can now be removed. To overcome the adhesion of the gasket and to avoid damaging the cover, one cuts along the gasket surface with a cutter at various spots until the cover has come off the crankcase (Fig. 2). The ends of the two camshafts are now free in their bushes.

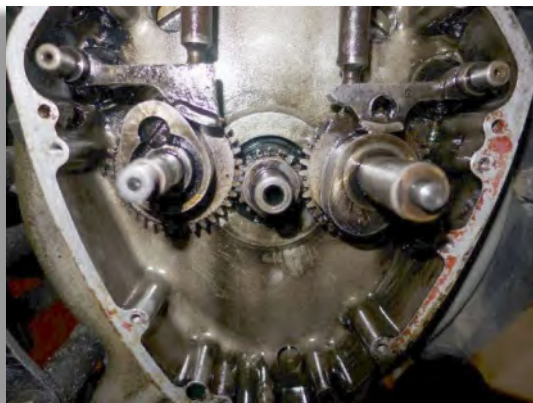
*Figure 4: Contents of the timing cover with the two camshafts and their respective rocker arms. Note the moveable inner part of the exhaust cam shaft for the valve lifter.*

The lower rocker arms are now free in their bearing bushes of the crankcase (Fig. 4). The inlet and exhaust valves must open and close at the correct piston position. Therefore, the three positions of the two valves and the piston must be coordinated with each other via the three corresponding drive gears on the camshafts. The valve timing setting is unique and was marked when the engine was manufactured (Fig. 5).

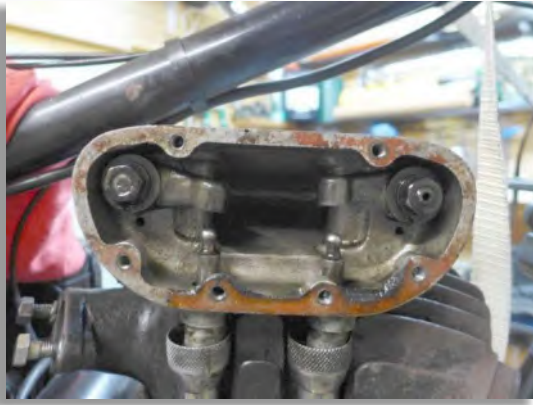
*Figure 6: The rocker box on top of the cylinder head. Note the cups for the pushrods at the rocker arm ends. The rocker box cannot be shifted aside until the pushrods are lowered.*

To remove the deeper 1937 Model 9 rocker box, which is bolted to the cylinder head, both pushrods must be lowered. Otherwise the upper frame tube will be in the way (Fig. 6). To do this, one needs pull the two lower rocker arms out of their bushes. At this point, it makes sense to check the running surfaces, which may have to be polished. New spares are available from the Marston Sunbeam Club. The cams on their shafts should also be inspected and refurbished in case of need. We have found them in excellent condition.

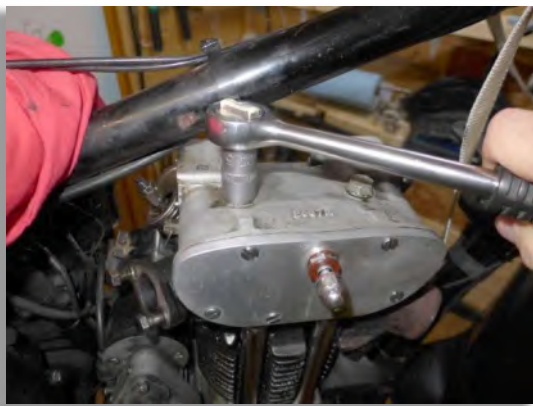
*Figure 7: Loosen the bolts of the rocker box.*

Now the upper rocker arm housing can be unscrewed from the cylinder head (Fig. 7). The outer valve covers must first be removed. There may be washers on the cylinder head bolts into which the rocker arm housing bolts are screwed. These must be reinstalled later (Fig. 8). Remove the push rods. They are picked up by cups of the rocker arms and it is advisable not to change the fits of the round rod heads and cups. It is therefore important to ensure that the push rods are later installed on the original side and with the original orientation. They should be marked accordingly.

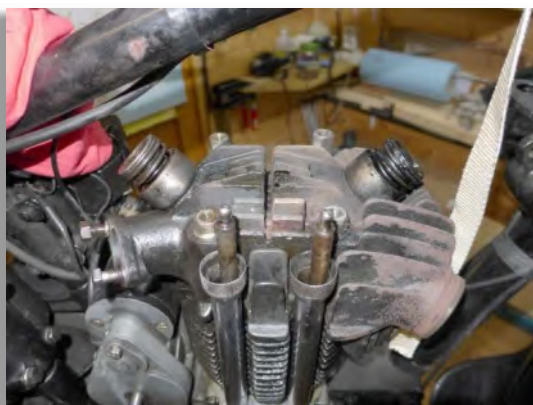
*Figure 8: The cylinder head without the rocker box.*

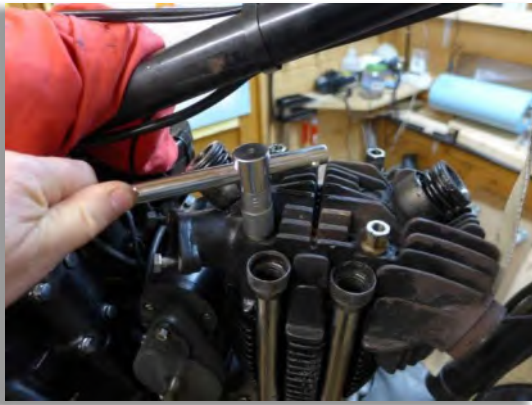
Figure 9: Diametric loosening the bolts of the cylinder head.

The cylinder head is now exposed and its bolts must be released progressively in a diagonal pattern to prevent warping (Fig. 9). Before removing the head, check whether hardened caps rest on the valve heads and secure them if necessary (Fig. 10). They are easily lost. The Sunbeam does not have a cylinder head gasket and special care must be taken not to damage the two connecting surfaces. If the head cannot be easily lifted off, light hammer blows near the heavy casting of the exhaust port, which are transmitted via a piece of wood, will help (Fig. 11). Avoid striking the fins!

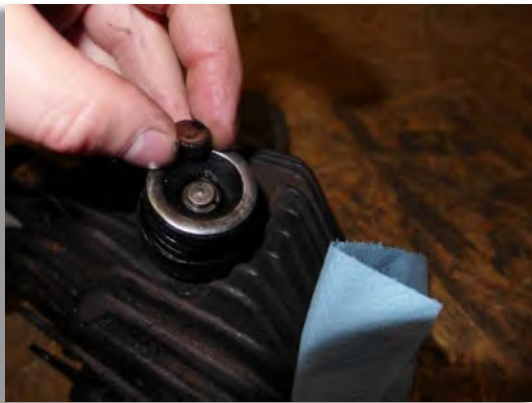
Figure 10: Hardened cups protect the valve tips against wear.

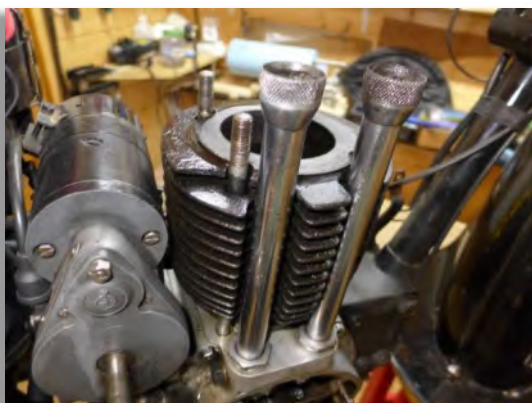
Figure 11: The Sunbeam has no cylinder head gasket and the surfaces must not be damaged.

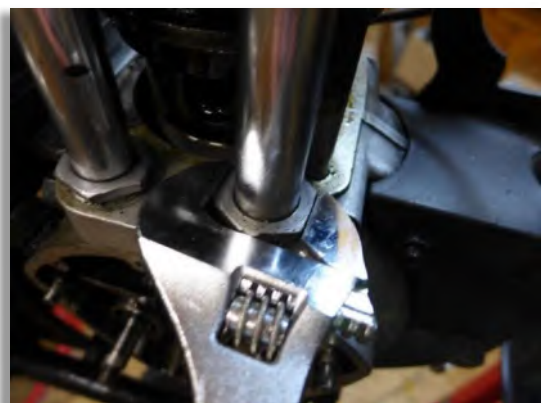
Figure 12: The push rod tubes are screwed into the crankcase but not into the rocker box.

Now the push rod tubes can also be unscrewed from the crankshaft housing (Fig. 12). As soon as the cylinder has been lifted, wrap a cloth around the connecting rod so that nothing falls into the crankcase. To release the piston, remove the two circlips and then remove the gudgeon pin. If the gudgeon pin cannot be pushed out, the piston must be heated up accordingly with the heat gun. **Caution:** If one wants to use the piston again, its orientation should be marked, ideally on its underside so that it can be used again later with regard to the direction of travel. A wrong orientation of the already run-in piston otherwise leads to increased wear.

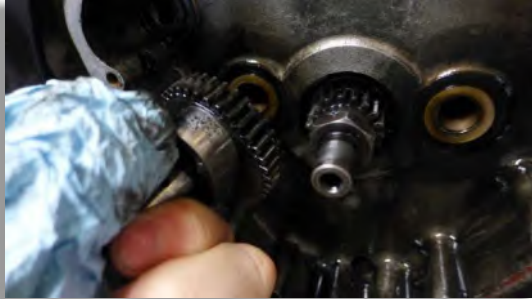
Figure 13: Since the camshaft positions are unambiguously referenced by marks the shafts can be pulled out of their bushes.

**Now the two camshafts** can be removed from their bushes (Fig. 13). Loosen the hexagon nut on the crankshaft (Fig. 14) and pull off the gear. **Caution:** The timing side shaft has a left hand thread. The primary chain and the clutch on the drive side should not yet be removed, since the crankshaft can be blocked with them and the rear wheel brake. **Caution:** On the crankshaft there is a perpendicular key that determines the position of the cam drive gear (the central gearwheel) for controlling the camshafts (Fig. 15). It falls out easily and must not be lost. The lower timing chest is now empty.

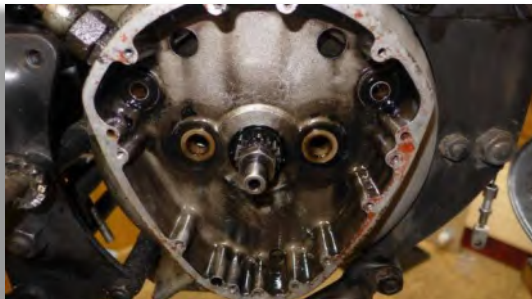
Figure 14: The timing case is cleared of its parts. The small hole at the lowest end acts as an oil pipe from the sump to the timing case and then to the oil pump. The central crankshaft is hollow. It acts as an oil pipe to the con rod big end. On the upper left side is the connection to the vent pipe.

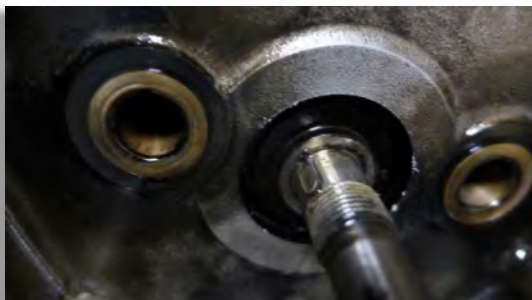
Figure 15: A perpendicular key on the crankshaft defines the unambiguous position of the timing gear.

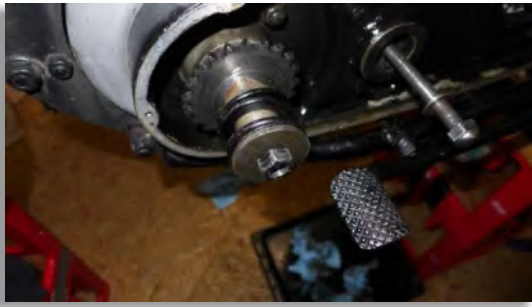
*Figure 16: The cush drive inside the primary chain case. The central nut is locked by an already removed cotter pin.*

On the drive side, the primary chain case must now be removed after the oil has been drained off there as well. Before removing the clutch, unscrew the hexagon nut (note the split pin) of the crankshaft on the drive side (Fig. 16). This needs to be undone whilst the primary chain and clutch are still in place, which act as a brake for the crankshaft. Analog to the timing side, the shaft is fixed via the primary chain, the clutch and the rear brake. Then the entire cush drive including spring, pinion and the dynamic seal underneath with its oil scroll can be removed (Fig. 17). If the hexagon nut on the cush drive is too tight, the small end of the con-rod can be fixed to behind the cylinder head bolts, but dismantling by using the primary drive is the far better option (Fig. 18).

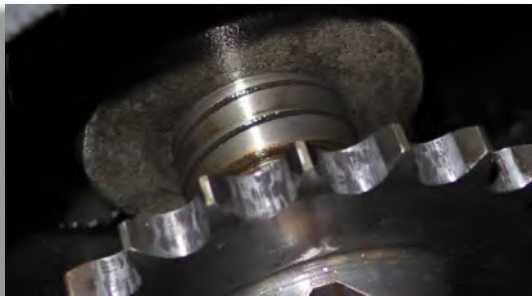
*Figure 17: When pulling off the drive sprocket the oil scroll dynamic seal with its worm grooves becomes visible. The seal rotates counterclockwise and the grooves transport leaking oil back into the crankcase.*

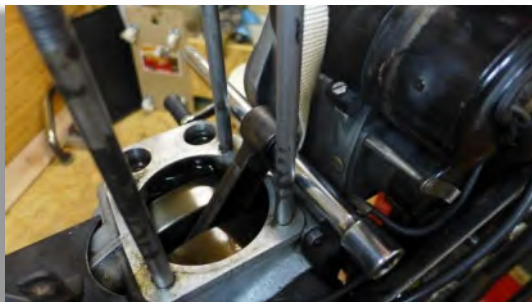
*Figure 18: The conrod in the flywheel inside the crankcase. (To unlock the nuts on the crankshafts a bolt should not be positioned into the small end unless great care is taken not to mark the bearing face.)*

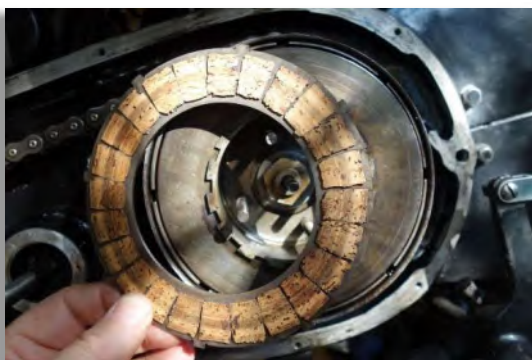
*Figure 19: Dismantling the clutch.*

Now the clutch can be removed. After the clutch and friction disks and the inner clutch cage have been removed (Fig. 19), one reaches the thrust washer that covers the clutch roller bearing on the outward side.

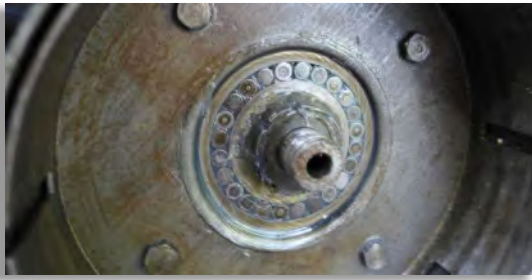
Figure 20: The clutch rollers inside their housing. The rollers are not positioned in a cage but are freely moving in a housing consisting of a front and back thrust washer and the inner and outer race (here well lubricated). When the outer cage is pulled out, all rollers will fall out.

**Caution:** The rollers of the roller bearing are not located in a cage, but lie loosely on an inner ring. They fall out immediately when the outer clutch cage (which also acts as the outer ring of the bearing) is removed with the primary chain (Fig. 20). One can catch them with a cake tray or similar (Fig. 21). Then the inner ring of the clutch roller bearing and the inner washer covering the clutch roller bearing on the gearbox side can be pulled off.

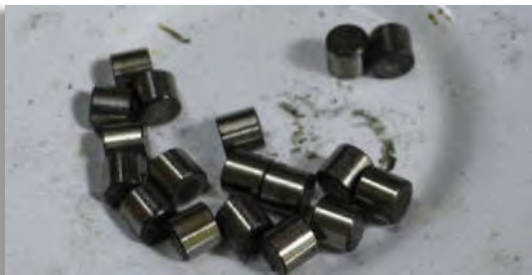
Figure 21: The clutch rollers.

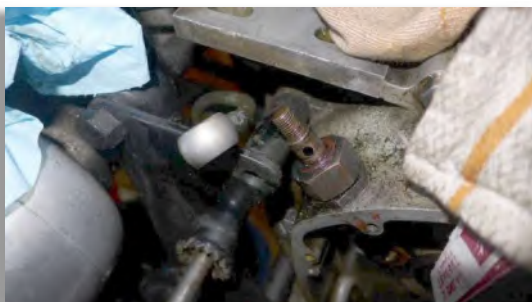
Figure 23: Disconnected vent pipe at the timing cover.

Since the primary chain case is no longer in the way, the mounting nuts of the magneto dynamo unit (magdyno) on its platform behind the cylinder are now very easily accessible. The magneto does not necessarily have to be detached from its Bowden cable. It is a simpler job to remove the handlebar control than extract the cable from the magdyno and is an opportunity to lubricate the cable and adjust the points whilst on the bench. The whole unit can easily be positioned to the side so that it is not in the way. In addition, the two breather pipes for the timing case and the oil tank can now be unscrewed (Fig. 23 and 24).

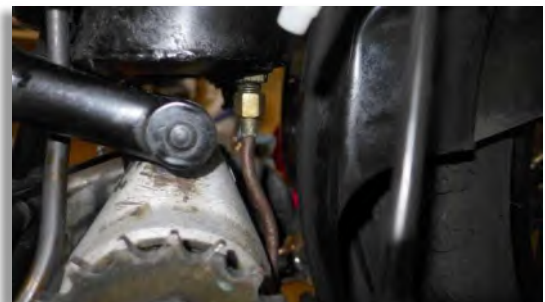
Figure 24: The vent pipe of the oil tank can now be unscrewed.

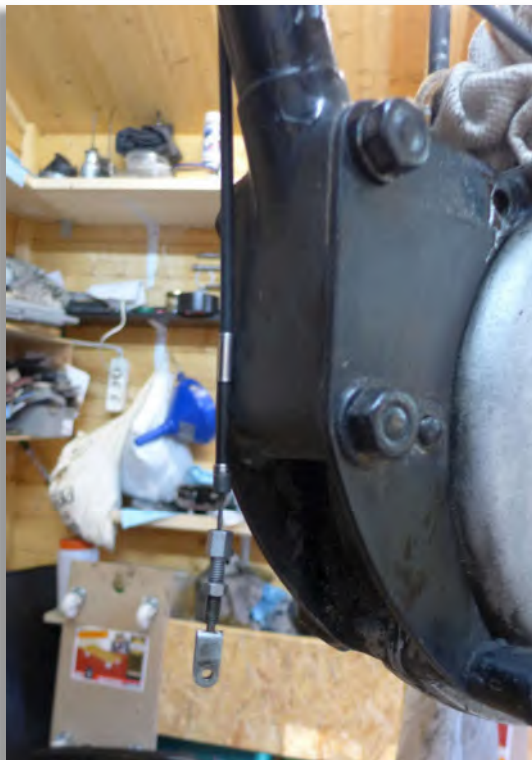
*Figure 26: The two front carrier plates.*

The two front carrier plates are also removed (Fig. 26). However, the lower carrier bolt (Fig. 27) cannot be pulled out yet because it is blocked by the frame. The crankcase together with the two rear carrier plates must be lifted first.

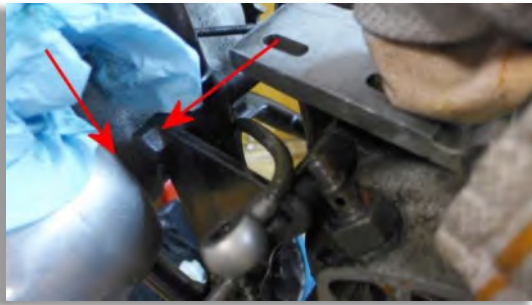
*Figure 28: The upper rear bolt of the two carrier plates cannot be pulled out in its regular position. The gearbox is in the way and must be pushed aside.*

However, the upper rear bolt of the two carrier plates is again blocked now by the gearbox (Fig. 28). Therefore, the pin for adjusting the gearbox position must be pulled out completely in order to be able to tilt the gearbox accordingly. Only then all bolts can be removed and the motor block together with the rear carrier plates can be lifted (Fig. 29).

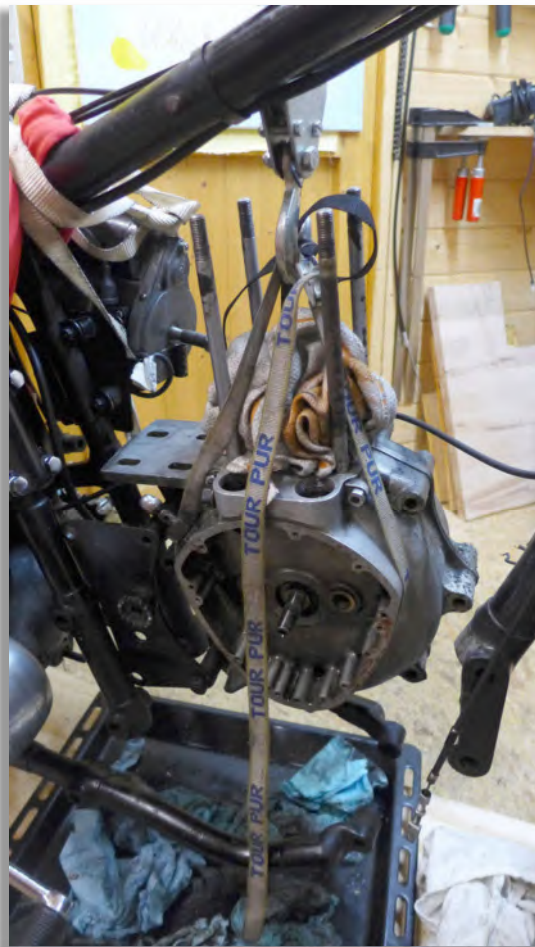
*Figure 29: The crankcase in the hoist before dismantling the front carrier plates. The motorcycle was lifted down onto a trolley.*

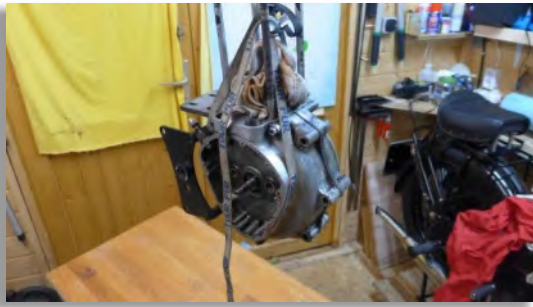
*Figure 30: The crankcase is lifted out of the frame, the motorcycle on the trolley pushed beside and the case is then lifted onto a bench (working plate).*

The remaining motor block weights about 21 kg. One should therefore use a hoist to first lift the whole motorcycle back to the ground and push it aside (trolley) after lifting the engine out of the frame. The engine can then be lowered onto a work platform (Fig. 30). The rear carrier plates are unscrewed (Fig. 31) and the two halves of the crankcase can be separated.

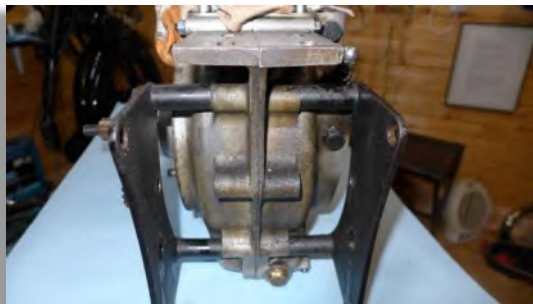
*Figure 31: The crankcase on the bench (working plate). The rear carrier plates are still attached.*

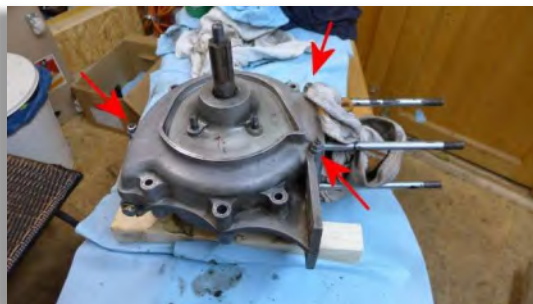
*Figure 32: The crankcase on the bench without the rear carrier plates. The arrows indicate the three bolts which hold the two halves together.*

Loosen the three smaller bolts (two at the cylinder base, one at the bottom) that still hold the two halves together (Fig. 32). To separate the two halves of the crankcase, use a cutter as for the cover of the timing case (Fig. 33).

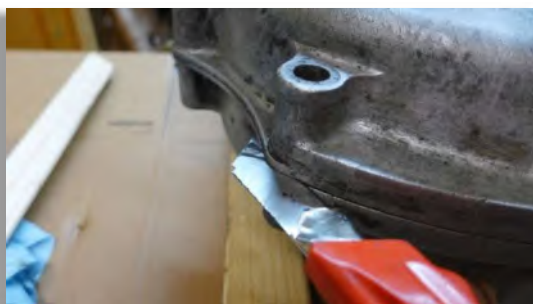
*Figure 33: Opening the crankcase. Like for the timing cover one should not apply force but the careful use of a cutter blade to avoid damage.*

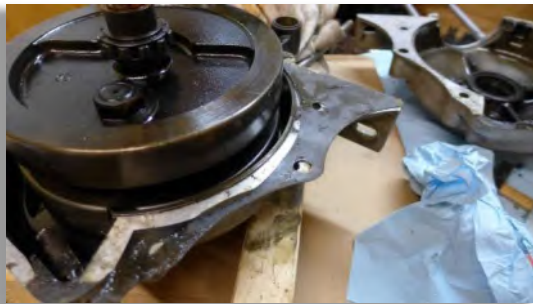
*Figure 35: The old 0.35 mm gasket between the two halves of the crankcase.*

Between the two halves of the crankcase we found a paper gasket of about 0.35 mm thickness (Fig. 35). As a replacement we made a new gasket of 0.5 mm thickness. However, we later found out that there was no gasket installed by the works. It must have been installed during an earlier overhaul. Hence, we waived a gasket completely (see below).

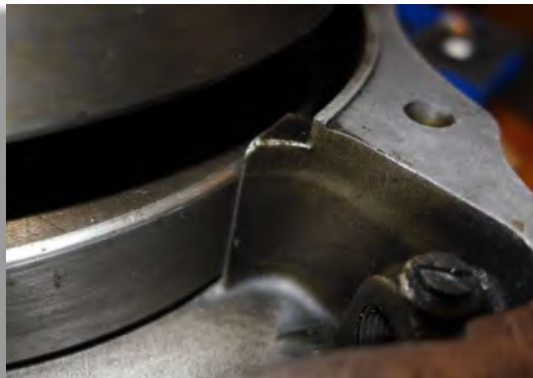
*Figure 36: The blade of the oil separator on the timing side next to the hole for the oil drain plug with its filter.*

We thoroughly cleaned the case for inspection and found that the blade of the oil separator on the timing side was in good order (Fig. 36). However, the blade on the driving side was significantly disturbed (Fig. 37). The reason for the damage remains unsolved. We can only guess that parts of a damaged shim washer we later found on the crankshaft timing side (see below) somehow found their way to the blade on the driving side.

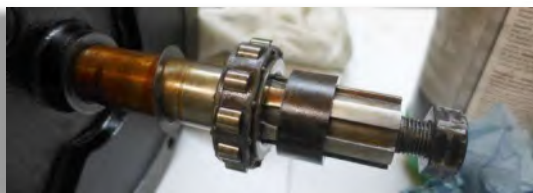
Figure 39: The imperial timing side LRJ1L (alternatively CRL8) roller bearing on the crankshaft driving side. Note that the LRJ series represents various bearings of different size and designs. The bearing for the Sunbeam must have a lip to avoid axial shaft movement. There are shims on both bearing sides. They are for adjusting the shaft end float.

**The crankshaft** is seated on three bearings. The type of bearing varies across the model years. On the drive side, an imperial RLS8 ball bearing is on the outside (Fig. 38). On this side, an imperial roller bearing (CRL8 or LRJ1) takes the main load (Fig. 39). The dimensions for both bearings: outside diameter 2.25" (57.15mm), inside diameter 1" (25.4mm), width 0.625" (15.875mm). The axis on the timing side is supported by a metric RMC22L bearing (Fig. 40). It has the dimensions 50 x 22 x 17mm. All bearings are a sliding fit on the crankpin, they are not press-fitted. At this point it is advisable to inspect the races and rollers for wear if one has not yet decided whether to renew the bearings.

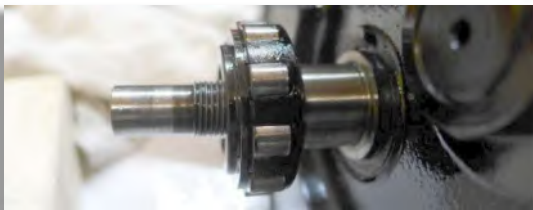
Figure 40: The metric timing side RMC22L roller bearing on the crankshaft timing side (,L' indicates a lip on the bearing race). It is a metric bearing of 50mm outer diameter, 22mm shaft diameter and 17mm width.

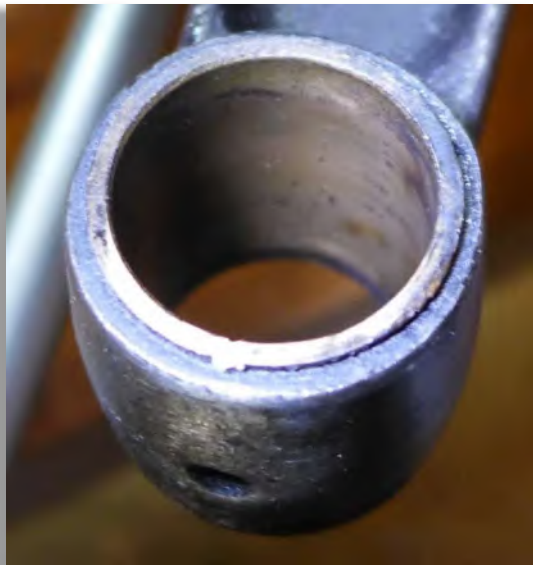
Figure 42: The small end phosphor bronze bush in good condition.

Check this using the gudgeon pin – there should be no discernable play or scoring. This is an easy bush to replace (Fig. 42). Make up a simple puller with a long bolt and suitable sockets. Any replacement must be reamed to fit as the conrod eye squeezes the new bush when it is pressed into place. Low cost adjustable reamers are available on eBay.

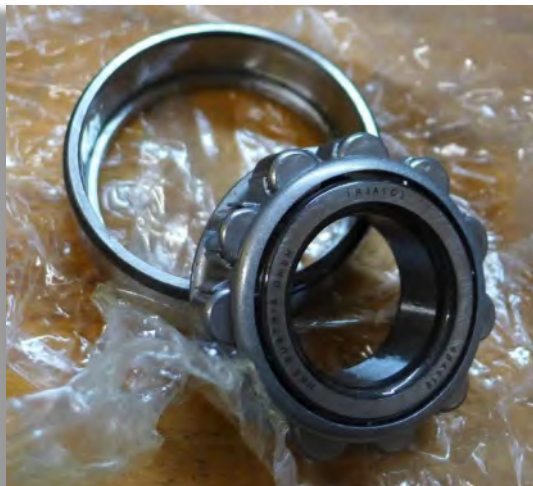
Figure 43: The imperial timing side LRJ1L (alternatively CRL8) roller bearing on the crankshaft driving side. Note that the LRJ series represents various bearings of different size and designs. The bearing for the Sunbeam must have a lip to avoid axial shaft movement. There are shims on both bearing sides. They are for adjusting the shaft end float.

In many ways the 'king' of bearings, as they can take a high loading (Fig 43). But they do eventually wear out. In the Sunbeam the big end roller bearing receives oil from the oil pump – this floods the bearing at near zero pressure. The two crank roller bearings (and drive side ball race) rely on oil splash. It is not too easy to assess wear once the bearings have been removed, but in situ one may be able to feel play or roughness in the big end and main bearings by lifting and dropping the conrod/crank pin. When dismantling look for signs of 'cooked' brown oil – like a well-used frying pan - the worn bearing will run hot and overheat the oil locally. With the bearing out, look for pitting both on the roller surface and the race surface and any tracking or grooving in the parts. Early warning signs are to see a

frosted/grey surface on the rollers or races – they are beginning to eat one another and will continue to do so! If all looks good add a very thin coat of oil and feel for super-smooth running. Any checks in movement are the sign to replace. Some roller bearings have a ‘lip’, often denoted by an L at the end of their code. Make sure that the new bearing corresponds to the one coming out/original specification. Specialist suppliers have these bearings – whether they actually source them from countries like China where standards are much lower is difficult to tell – but in the absence of new ‘old stock’ there is little choice.

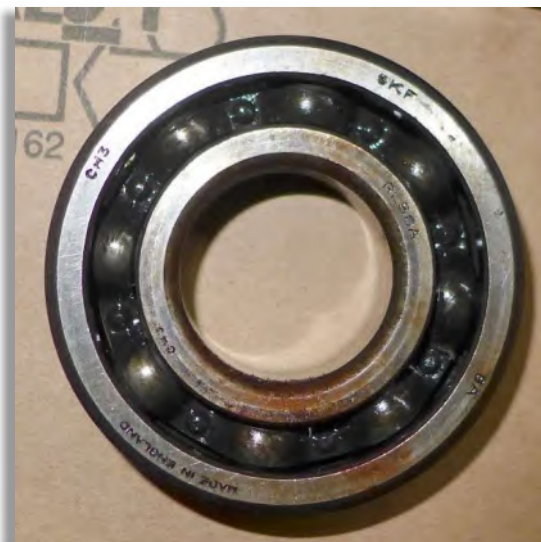
Figure 44: The RLS8 ball bearing on the driving side.

The ‘cheapest’ of the bearing types and most likely to suffer from wear (Fig. 44). Wash out the race and look for any debris. With the bearing ‘dry’ put a finger or two within the race and spin the outer. If it clatters round or shows any chattering or play then bin it. They will continue to run until they disintegrate completely. Replacement – well, one can buy replacements from China & India for pennies and they will last a matter of hours, despite arriving in (fake) SKF packaging. Only buy branded bearings from an established bearing company. When one has the new bearing to hand one will realise just how worn the old one was. The ball race takes quite a load on the drive-side and is last to receive oil, so replacement is likely to be a necessity and it should be treated as a service item. Do not be tempted to fit a sealed bearing where grease is already added. This bearing needs oil for lubrication and cooling – if one take the seals out of a new ‘sealed’ bearing one will be surprised as to how little grease is there.

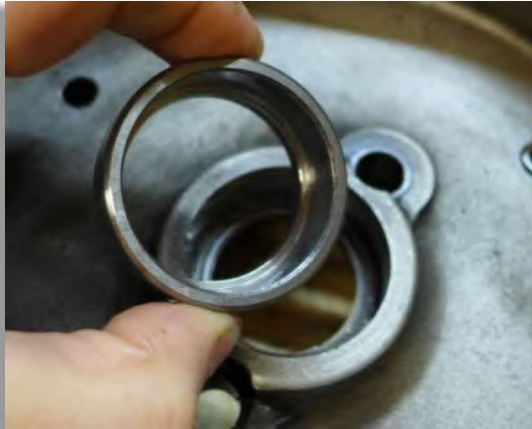
Figure 45: The RMC22L race. Note the lip on the race which avoids axial shaft movement.
