1937 Sunbeam Model 9

Valve guides – Wrong material, big effect

**Thomas Eversberg**

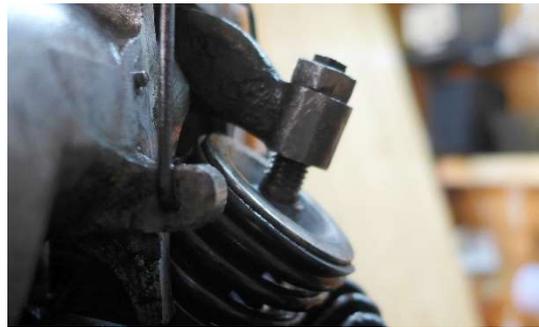
After passing Faschinajoch and Silvretta Pass, I realised that the engine was heavily oiled. Later at home, I discovered that the oil supply pipe in the head was overflowing on the inlet side because of a too small clearance between valve and guide. The assembly accepted much less oil than normal. This was annoying but it would not damage the valve assembly. However, at a 14% climb towards a hotel high above Sölden, the engine lost power and exhaust gases were forced through the carburetor. The exhaust valve had extreme clearance of a few millimeters, so it did not open sufficiently. In addition, the hardened valve cap had fallen out (I found it later between the fins of the cylinder head) and the clearance became even larger. An adequate clearance adjustment was no longer possible and the geometry between valve stem and rocker arm tappet was no longer symmetrical. We had to return and drive another 100 miles without the valve cap (the valve tip was later slightly deformed but could be flattened again).

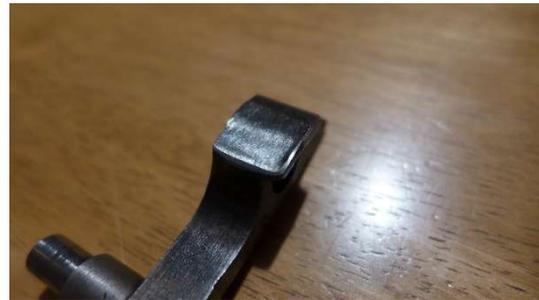
At home I found that the surface hardening of the exhaust side follower was breached and worn. Through emails and phone calls with Chris Odling, I learned that an oil feed to the exhaust valve guide is not necessary. Such engines run "oily" and one can feel it on the oily soot with fingers. On the later Sunbeam motorcycles like mine from 1937, it was common that only the inlet valve was lubricated. And bronze, often used for modern machines, is not a suitable material because

one would have to allow too much clearance not to jam the valve stem. And exactly that happened with my exhaust guide. A few weeks before our trip, I needed new valve guides and asked my local engine shop to make two. The inlet valve and its guide are lubricated through a small feed in the rocker box by an adjustable taper valve (half a turn of the screw is just fine). The exhaust valve is not, though. The engineers meant well and used a "material that requires little lubrication". In fact, they had installed a bronze guide contrary to the information on the drawing. The exhaust valve was jamming, giving excessive resistance through the rocker arm and pushrods, and wearing out the cam follower (note that the coefficient of thermal expansion for Bronze is about 50% larger than that for iron so that the bore diameter respectively decreases). This in turn increased the gap between the cam follower and rocker arm. Valve clearance grew dramatically, necessarily changing the geometry at the valve tip, which was then deformed on one side. Instead of bronze, the valve guides should be made of SG cast iron (grade 250) with a 1/1000-inch fit in the cylinder head. The clearance in the guide on the inlet side should be 1.5 thou and 2.5 thou on the exhaust side. The guides in the club shop do not distinguish between these two values, though. As a rule of thumb, one should feel the clearance by inserting the valve into the guide and just feeling a very tiny movement on the valve disk at the inlet. At the exhaust port, one should feel the valve move noticeably. The clearance specifications refer to cast iron. At least for my 1937 Model 9 the inlet guide needs an oil feed hole in the correct position.

Chris had reworked my cam followers and had them hardened so that everything is in order again. He also gave information for making my own guides, which I report here (if it's not already somewhere):
