1937 Sunbeam Model 9 Rocker Box & Arms

Thomas Eversberg

2022

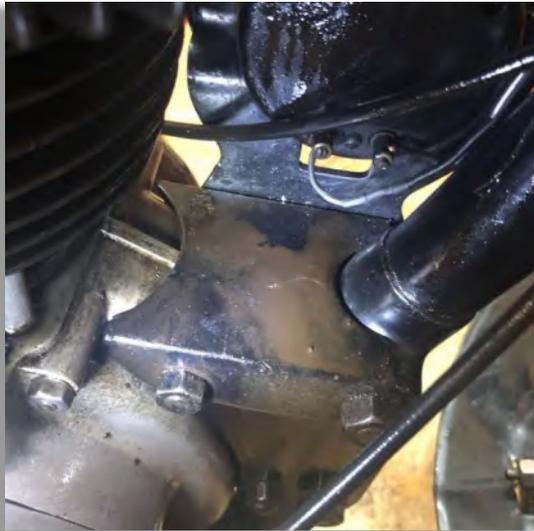
Figure 1: Brown oil on the lower motor mount cover indicated a problem with the valve guide.

After a trip of about 100 miles the exhaust valve spring was suddenly covered with brown oil as were the parts below the valve. There was no excess oil at the inlet valve. The cause could have been somewhere between the rocker shaft in the rocker box and the valve guides since the outer side of the rocker shaft was significantly covered with oil, as well (Fig. 1 and 2).

After investigating the barrel and head I discovered that the valve guide was worn, although new. Guides become worn quickly if the forces of the rockers are not axially applied to the valve tip. I therefore focused on the geometry of this unit.

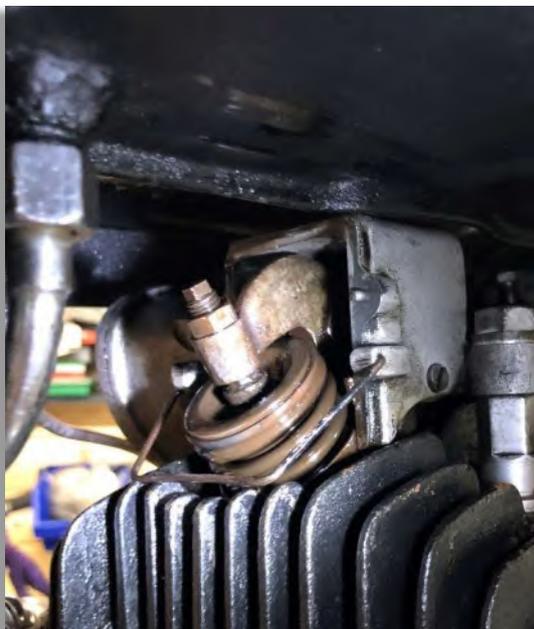
Figure 2: The exhaust valve spring covered by the same brown oil.

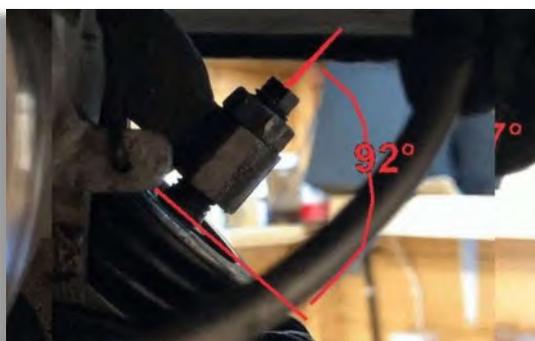
Figure 4: Rocker-to-valve angle for the closed valve.

Figure 5: Rocker-to-valve angle for the open valve

When the valve is operated the tappet should apply the force symmetrically onto the valve tip, i.e., only at half way between valve open and closed position acts the tappet exactly axially onto the valve tip (Fig. 3). However, I realised that the rocker collet applied the force axially only when the valve was open and measured the respective angles between the adjuster screw and the valve cup. Normally this is difficult to perform and contains large errors. However, modern smart phones offer respective measurement Apps with their camera. Either in real time or one uses already taken pictures. The situation for my case can be seen in Figure 4 and 5.

The position angle difference between the open and closed valve was about 15° with an angle error of the order of 2° . Actually, the two angles should be symmetric around 90° , hence, 97.5° and 82.5° so that the axial force on the valve stem and, hence, the guide is balanced out best (symmetric). Only then is the guide best protected against wear. However, for my situation the situation significantly deviated from the desired positions.

Then I assembled the rocker box again. As expected, the open/close position of the exhaust rocker arm was still not as desired (see Fig. 4 and 5). Now the only option was to lengthen the exhaust pushrod by the above measured 2.5mm. Following Chris Odling's advice (see Fig. 7) I detached the ball from the pushrod by heating it with a blowtorch (Fig. 19) and ordered a matching packing ring out of silver steel at my local workshop for a tip into the coffee cup (Fig. 20). I then fixed the ring and the ball section to the pushrod with electronic solder (Fig. 21 and 22).

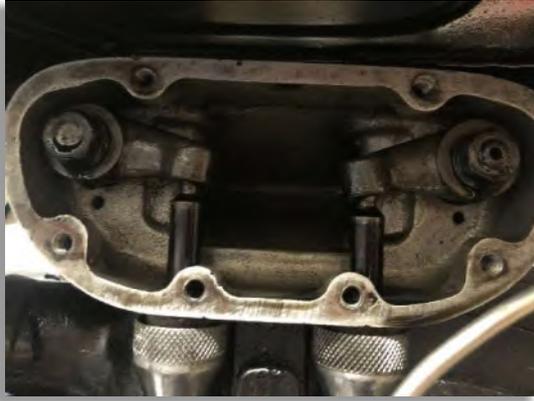
Figure 6: The open rocker box.

At this point it is important to note that the top end of the pushrod and, hence, the inner end of the rocker is always a 'constant' (Fig. 6), i.e., the outer arm angle and, hence, the tappet position cannot be altered by simply turning the tappet adjuster screw. For doing that one has only three options: For increasing the tappet height, one increases the rocker box height by shimming the head bolts. For decreasing the tappet height, one pulls out the shims or one lengthen the pushrods (Fig. 7).

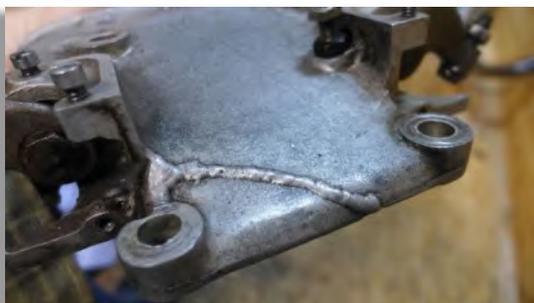
Figure 8: The welded upper part of the rocker box.

At this point it is also important to note that the four head bolts need to deliver a virtual plane. Otherwise the rocker box might break when its own bolts are fastened to the head bolts. Remember, a chair with three legs never wobbles but one with four legs can. Exactly this must have happened during the history of the machine because it once had been repaired by a respective welding seam (Fig. 8). So, either the bolts already have the correct length or one needs shims or washers for correction.

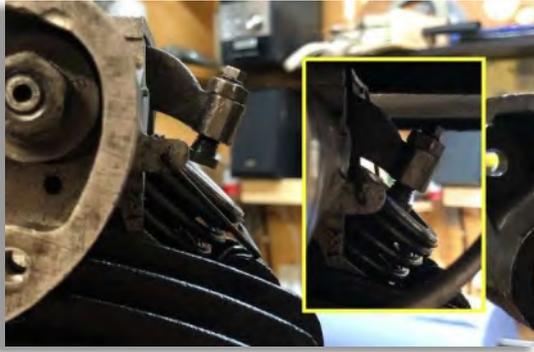
To estimate the amount of how much the bolts should be shortened I lifted the box with 2mm washers on the head bolts to lift the outer rocker arms. This amount in degrees can then be directly brought into relation to the respective angle of rotation upwards. And because we talk about relatively small angles we can apply this in a linear approximation. The situation is shown in Figure 9.

Figure 9: The outer rocker arm position after lifting the rocker box by 2mm. Inset: The situation before.

With the inner rocker arm in contact with the pushrod I estimated the angles with respect to the valve cup.

1. No washers on the head bolts:
 - a. Open valve: 92°
 - b. Closed valve: 107°
→ Angle interval: $\pm 7.5^\circ$
2. 2mm washers on the head bolts:
 - a. Open valve: 99°
 - b. Closed valve: 114°
→ Angle change: $3.5^\circ/\text{mm}$

Taking these values into account I obtained the following angles intervals for respectively shorter head bolts:

- 100° and 85° for 2mm shorter bolts
- $98,25^\circ$ and $83,25^\circ$ for 2.5mm shorter bolts
- 96.5° and 81.5° for 3mm shorter bolts

The second option matches best a symmetric rocker position which result in $+8,25^\circ$ and $-6,75^\circ$ from the perfect 90° position (axial force on the valve tip). So, taking these numbers into account the bolts should be shortened by 2.5mm. For this case, however, two central head fins should be ground off by 3mm so that they do not touch the rocker box.

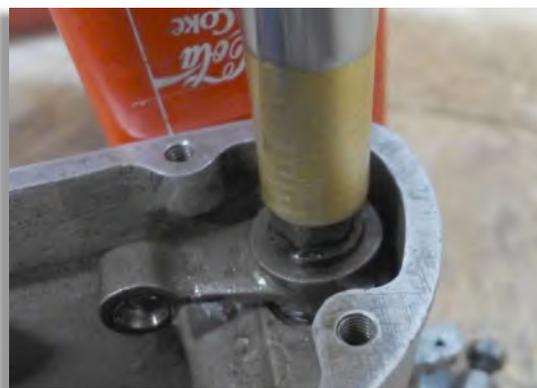
Figure 11: Applying a brass punch to loosen the inner rocker arm from the tapered shaft.

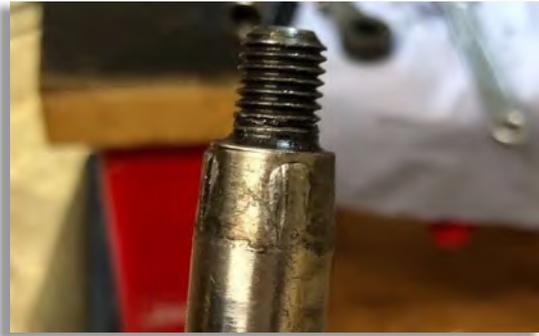
Figure 12: Worn keys in the shaft key ways.

In theory one first pulls the keys out of their keyways and only then pulls the axle through the bush. For my case, though, the two worn keys were heavily worn and sheared off. I found almost the same situation for the inlet valve (Fig 12). Obviously the two keys which go into the two rocker arm grooves take most of the pushrod load (Fig. 13). This seems to be confirmed by their worn surfaces. Many thousand hits by the pushrods will have a long-term effect. It was, hence, not surprising that the inner rocker arm was not hold in its regular position.

Since it was impossible to get the keys out I let it be done by a local workshop on a mill. They also made make new keys (Fig. 14). It is important that the keys have some little play on top so that the rocker arm can correctly bed on the taper and the Thackery washer can pass along the keys

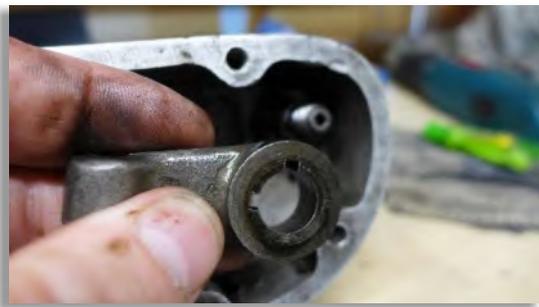
Figure 13: The loose inner rocker arm with its two grooves for the keys.

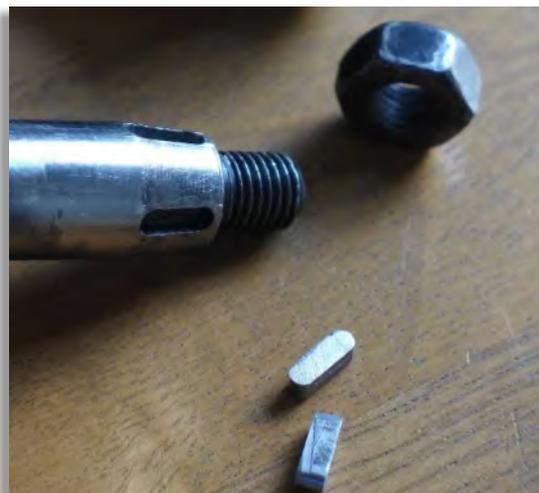
Figure 14: The tapered rocker shaft end with the two key ways and the new keys.

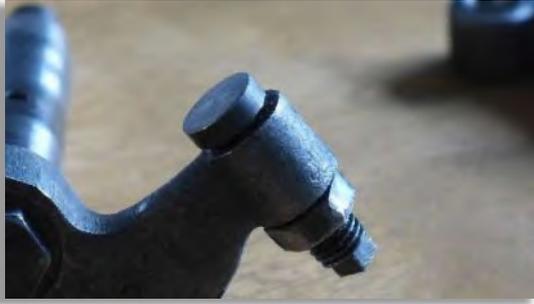
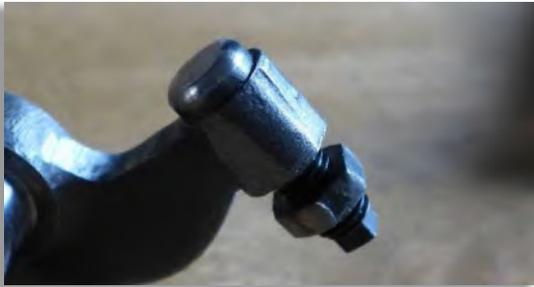
Figure 15: The exhaust tappet at its rocker arm. Its face seems to be flat at first sight but has a radius matching with the arm length.

Figure 16: The inlet tappet at its rocker arm. As for the exhaust tappet its face radius matches with the arm length. However, the outer part has been once unnecessarily ground off.

Another important part to check is the valve tappet. I first thought that the exhaust valve tappet has a rectangular cross-section in contrast to the inlet tappet (Fig. 15 and 16). The faces of the hardened tappets should not be flat, though, but should have a certain radius equal to the distance between the centre of the shaft and the centre of the tappet. This gives as near as possible a rolling action. This radius is about 45mm and the tappet has a diameter of about 10mm. With these numbers the resulting height for the tappet surface from edge to centre is only 0.3mm (calculated from the equations for a circular segment). Checking the two tappet faces again shows that both are slightly convex, indeed, and match well with this number. Hence, the outer phase at the inlet tappet is just "faking" the required round cross-section. It appears that a previous owner has exaggeratedly ground off the edge without calculating the required form.

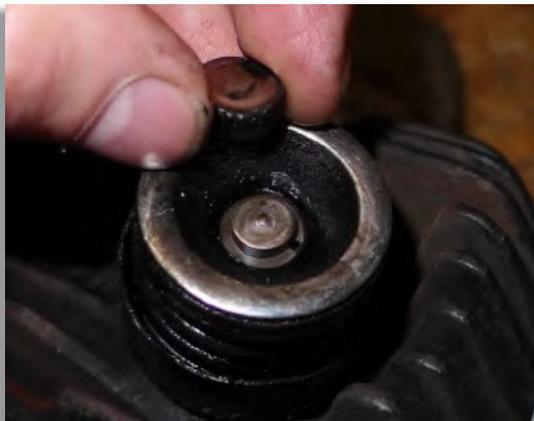
Figure 17: A hardened valve cap on the valve tip. New caps should be made out of silver steel with an inner diameter to a good fit to the valve tip. The top material thickness is 0.06". Then harden and temper.

- Extensive valve guide wear can be introduced by austenitic stainless steel because it acts very aggressively against guides out of cast iron in a poor lubrication situation. This can be avoided by nitriding the valves.
- Overhead valve Sunbeams have valve caps installed (Fig. 17). Failing that one would have to have the top of the valve hardened. A valve cap however is a better solution.
- Because of missing drafts and comprehensive information many people drag a valve out of a Sunbeam engine and think it is an original item. A lot of parts manufactured are wrong because they are copying a part out of a machine which are assumed to be original. For instance, meanwhile G&S Valves have over 30 drawings for a Model 9 Sunbeam valve.

I have installed phosphor bronze guides and nitride valves from GS Valves. The valves tips are hardened.

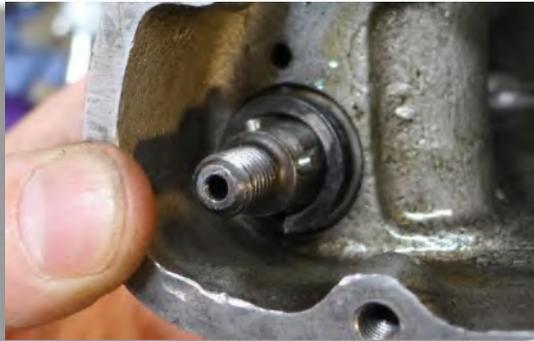
Figure 18: The new keys in the rocker shaft.

For assembling the shaft, I inserted the keys and applied some Loctide to the nuts and the tapered shafts. Note that the keys can only be fitted before the Thackery washers. One must therefore ensure that the keys do not protrude too high (Fig. 18).

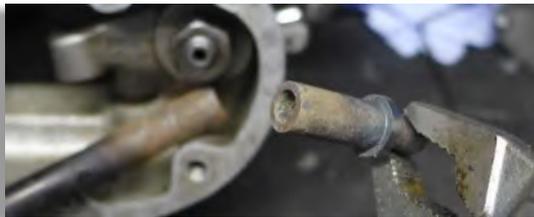
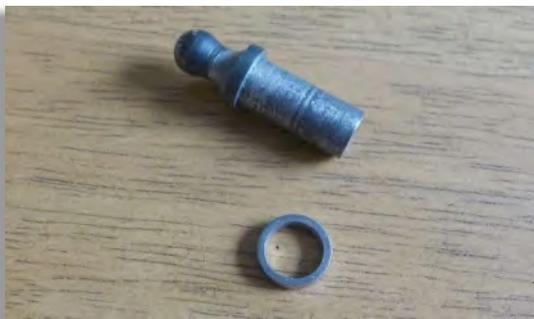
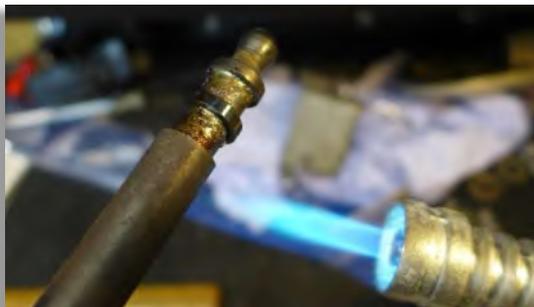
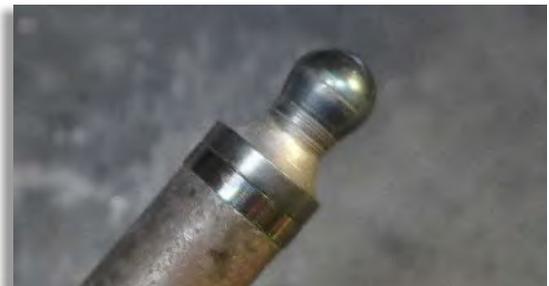
Figure 19: The ball section separated from the pushrod.

Figure 20: The balls section and the 2.5mm distance ring.

Figure 21: Soft soldering with a blow torch.

Figure 22: The finished pushrod with the distance ring.

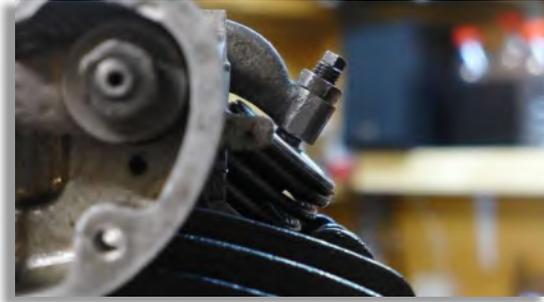
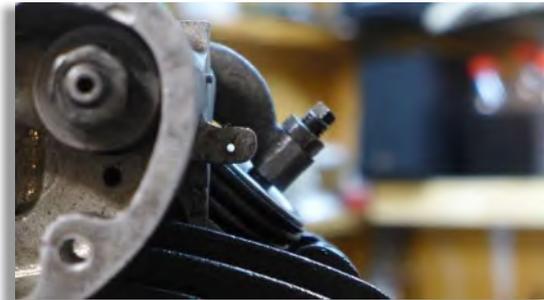
Figure 23: The final rocker arm geometry for the closed valve.

Figure 24: Figure 23: The final rocker arm geometry for the open valve.

The resulting geometry with the exhaust valve closed and open now meets the requirements Fig. 23 and 24). It seems that a slightly thicker ring (3mm) would have been better. However, the rocker arm would have been very close to the valve cup. Therefore, and in view of the small difference, I waived that.
