## **A beginners guide to Burman I – by Joe Rayner**

#### **An Oilyrag guide to the strip down and rebuild of the Burman Heavyweight Gearbox.**

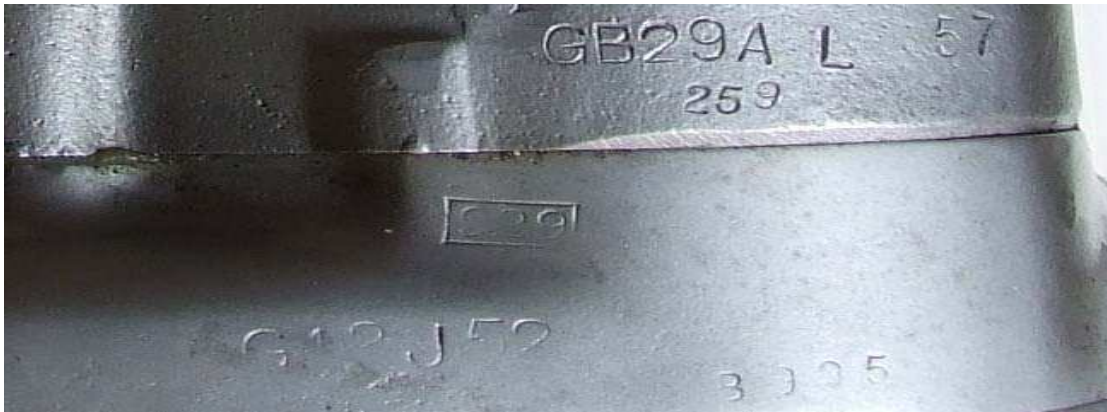
**Check the outside of the Gearbox prior to dismantling.**

You are looking for casing damage, cracks, galled nuts & screws, chewed inspection cap, mushroomed or stripped lower mount bolts. The next time you'll handle these parts will be on final assembly, so start your shopping list for any parts required.

You can also check the casing stamps which will have the month/year shown – look in the POC library for these, and the many Burman listings on the web. This gearbox appears to have a main casing from 1957, but the middle 'layer' appears to be from 1952!

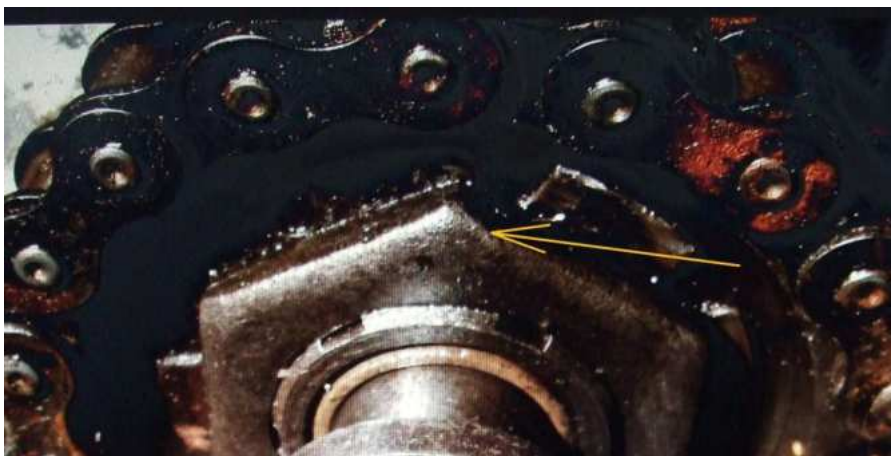
Tap the tabs of the lock washer back fully. Wrap a chain around the sprocket (if not on the bike) and trap the chain in a Workmate or vice. Spanners to fit the large nut will not be easy to find and you'll probably need to resort to using a medium size cold chisel or drift on one or more of the nut faces, a 1/8" or so from the nut hex. tops. Realistically, with the chain in the way, you are hitting at about a 45 degree angle. A solid blow from a hammer will jar the nut free and there may be next to no damage to the nut.

However if the nut looks decidedly second-hand (maybe even before you start!) then budget for a new one, and certainly a new lock washer from POC spares. Heating for a few minutes with a hot air stripper may help, especially if you suspect Loctite. Pull the sprocket off.

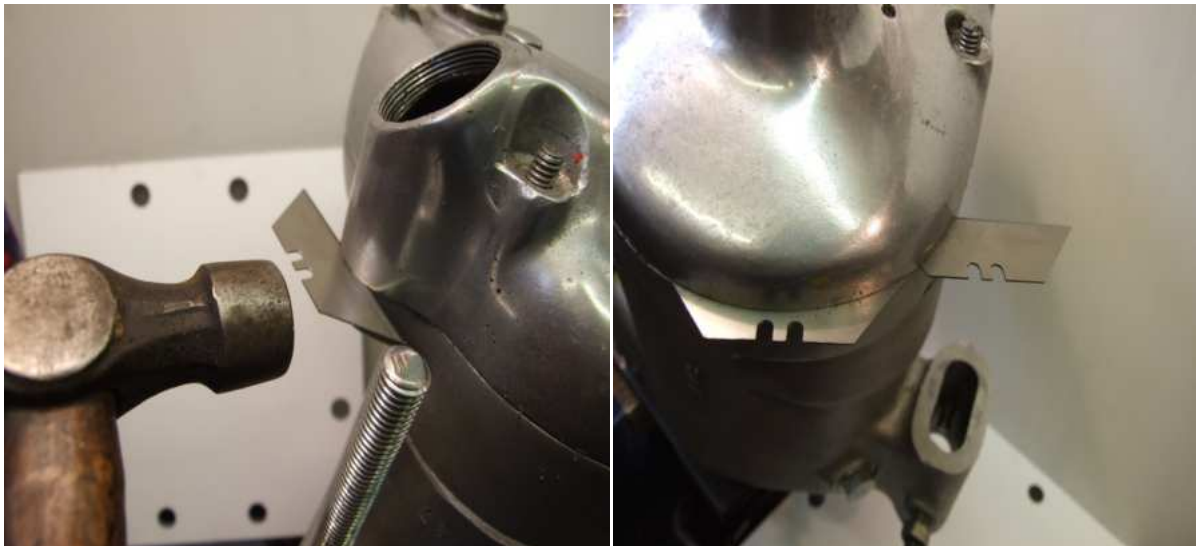
The place where the sealant has most likely to have been used sparingly is at the top, near the inspection hole. Hold a blade at 90 degrees to the casing and tap it gently with a small hammer - it will stretch the sealant. Tap it until the blade chamfer only is fully in, about 3mm. Start another blade nearby and the wedging/cutting effect will start to separate the covers .

Work steadily around the cases, rotating the blades around the studs, until the whole outer cover has moved away from the inner. Find a couple of flat pieces of scrap to gently lever the cover upwards – I used 2 brass Rally Plates here, and increase the gap to a few mm. until you are sure that the sealant has been cut through. Remove all blades / plates

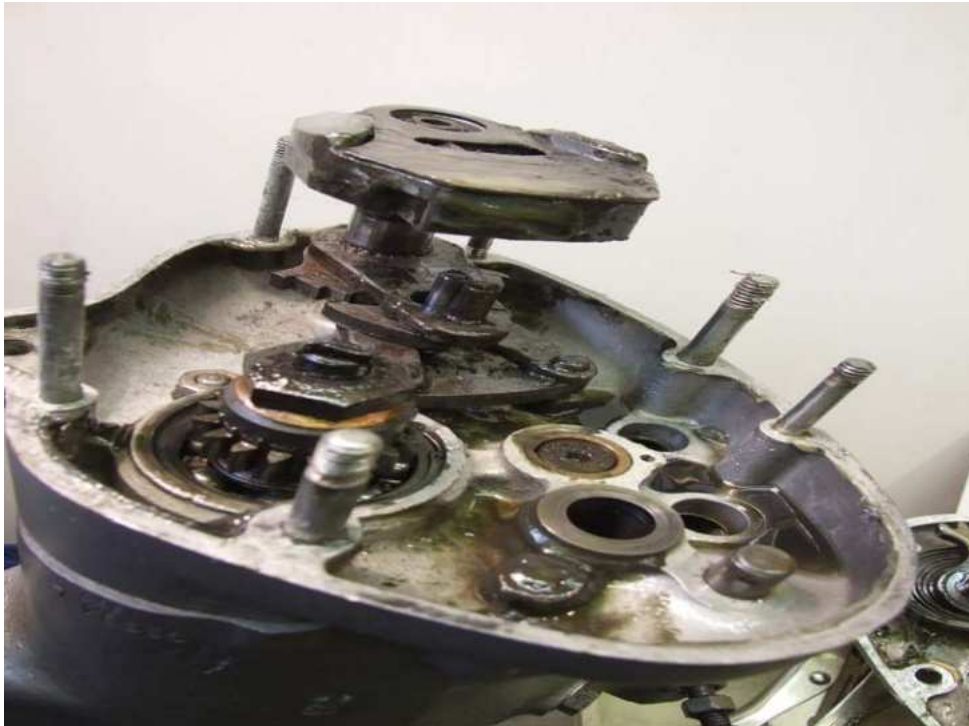
Inside ... with spring box almost ready to fall off.

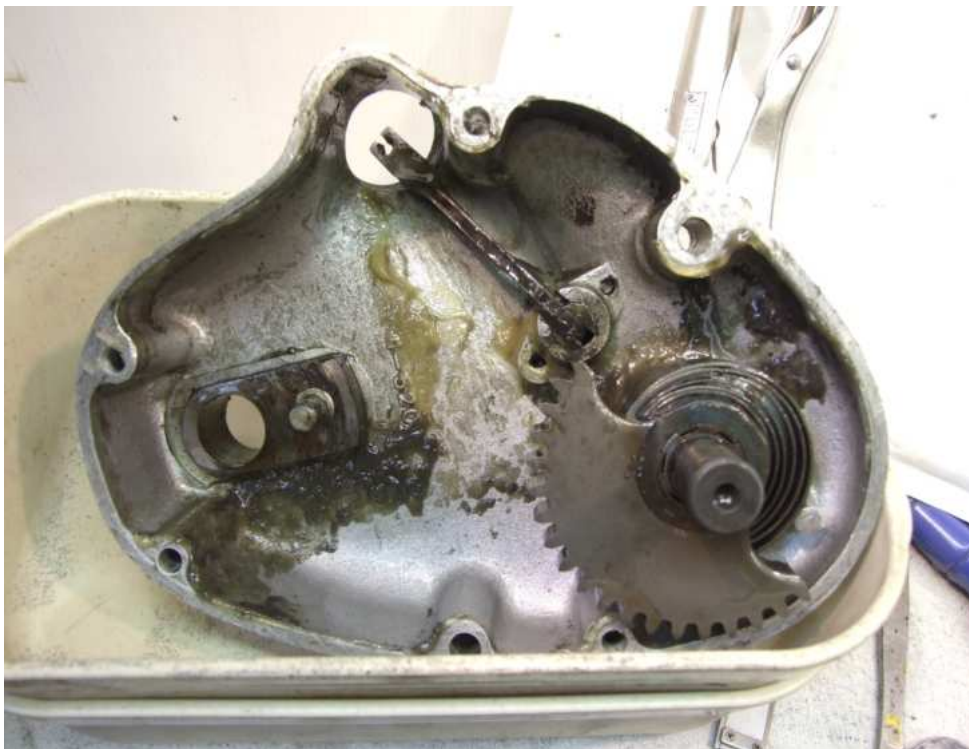
And, inside the front cover, the clutch lever assembly and, still coiled, the kickstart spring

Firstly you don't need to remove the steel plate with the hole/peg in it on the left of the picture unless it has been damaged or worn. The kickstart spring is still under tension and is attached to a peg in the casing directly behind the quadrant in this picture. To release the tension (gradually!) wrap a rag or piece of leather around the plain inboard end of the

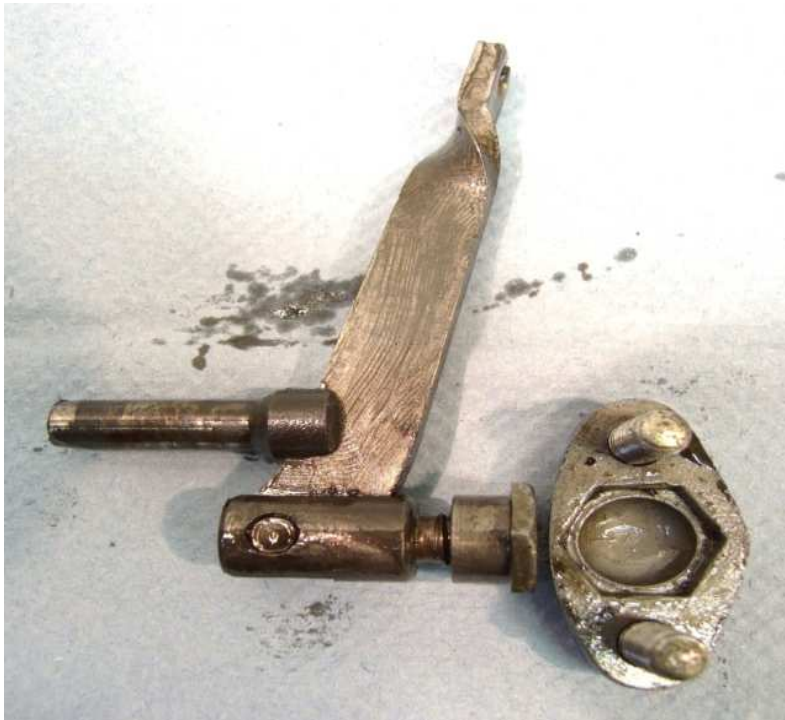
Remove the clutch lever assembly, shown here with its outer cast adjuster, bolts, and clutch push rod clevis.

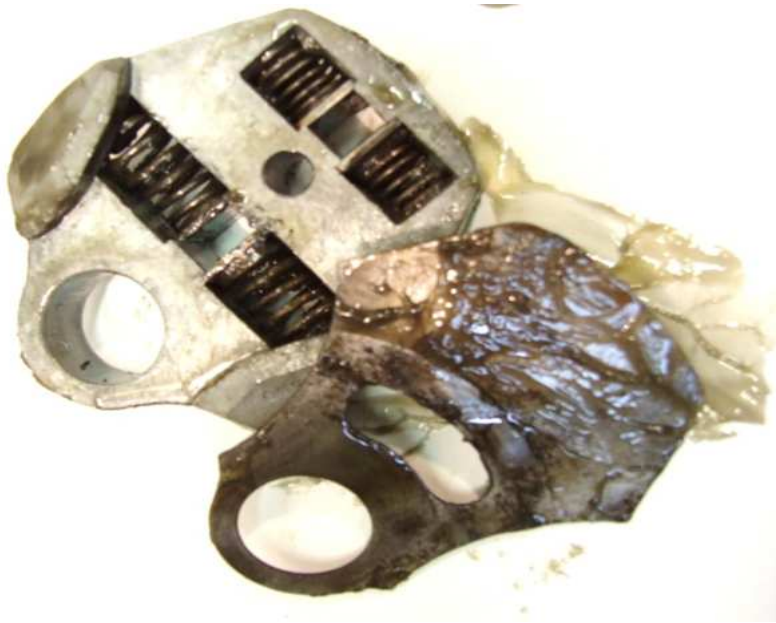
#### **What you see inside when the outer cover is off**

Firstly recover the spring box and its tin plate, and put aside for cleaning.

The centre section of the gearbox is now exposed, and the main parts now visible are :

The spring loaded kickstart ratchet assembly, attached by the gearbox mainshaft nut, mainshaft bearing, washer & circlip beneath. Shown with the short clutch clevis pin in situ, and pin removed in the second picture. It may have a loose  $\frac{1}{4}$ " ball bearing stuck to it.

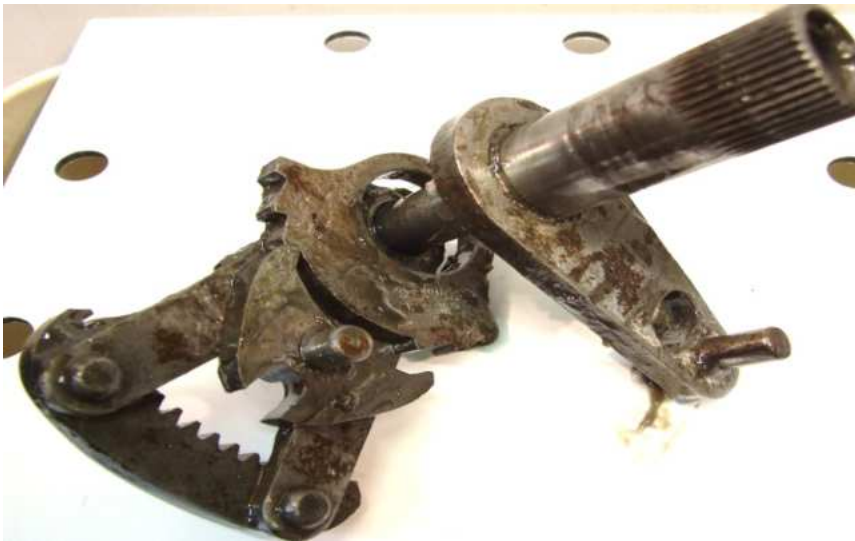
The gear selector assembly, with corresponding index marks. This assembly lifts away.

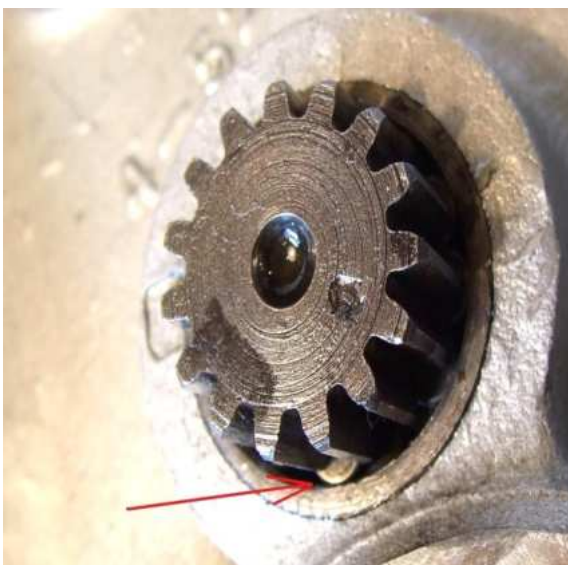
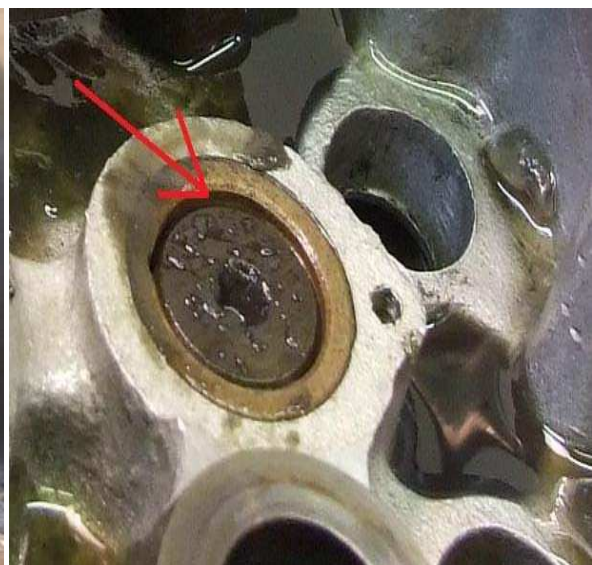
It leaves exposed the toothed selector shaft , beneath which can be seen the loose rollers that act as a bearing, sitting captive in a groove in the selector shaft.

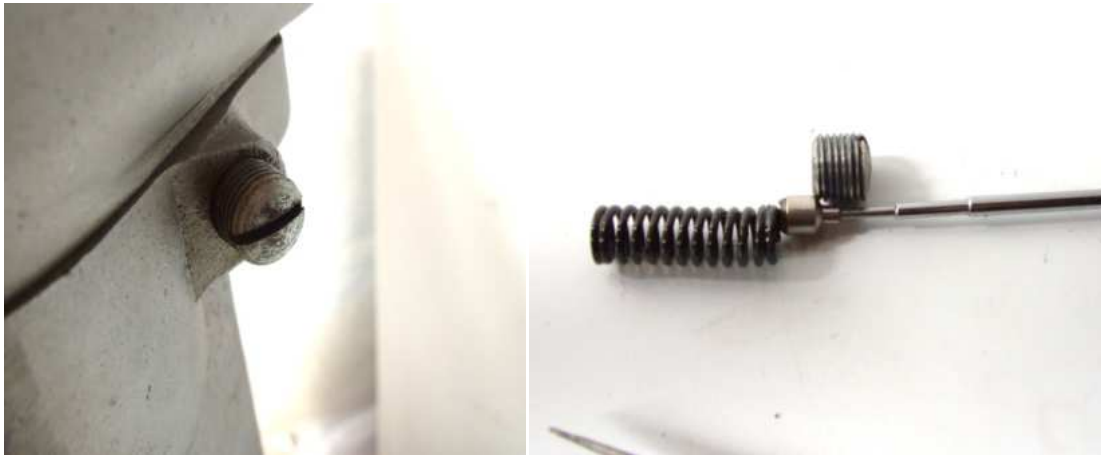
Back on the outside of the main gearbox casing , you'll find a large screw, and this holds a spring which pushes on a peg that relates to the various gear positions. Remove the screw and spring – a magnet may help.

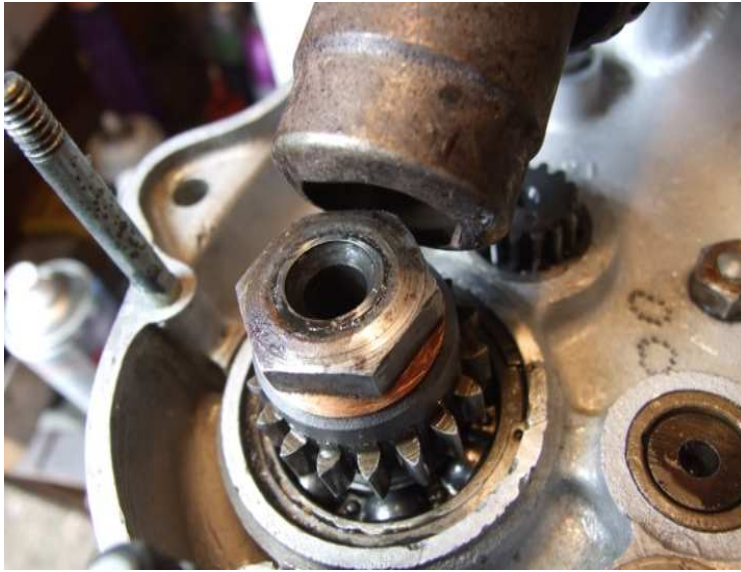
The kickstart ratchet components, including 'extra' copper washer, which shouldn't be there.

First task is to remove the nut holding the kickstart ratchet. It is attached to the mainshaft that passes through the gearbox and at its splined end it carries the clutch centre. To undo it means holding the clutch end stationary and one way to do this is to wrap a piece of leather around the splined part and grip it tightly in a vice, ensuring that no damage occurs to it. The nut on this gearbox was slightly suspicious – it had a copper washer that shouldn't have been there and also signs of Loctite. To melt the Loctite a hot air stripper was used – it has to heat the component to 275 C + - when it's bubbling, it's soft.

Use a 9/16 Whitworth socket and remove the (hot!) nut, followed by all parts of the kickstart assembly. Once the nut has been removed the shaft will be free and could be withdrawn from the clutch end of the box (mind it doesn't drop out) , but leave it there. Put just the (cold) nut back on for now, by a couple of threads.

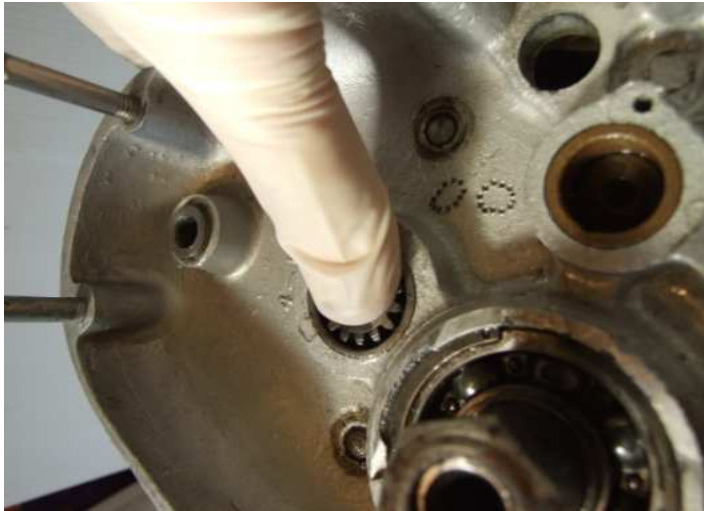
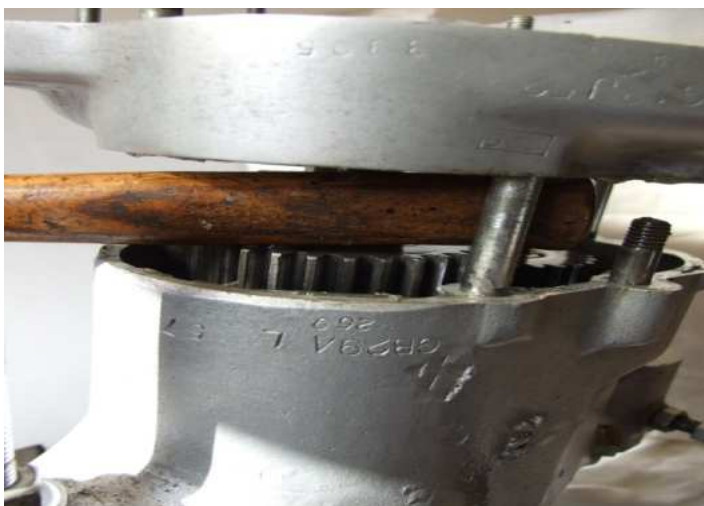
The middle layer is ready to remove, apart from the fact that this one was also glued, so out with the Stanley Knife blades again. Once the joint is free the casing can be raised by pushing your thumb on the selector shaft and lifting the cover with your fingers, but once it

is up about half an inch the very small selector shaft rollers will try to drop out, hence leaving the 3 nuts on. You may be able to catch the rollers on a magnet if the gearbox is vertical, otherwise they'll head for the floor. You're looking for 12 of those. Once they have been sorted out (if they drop into the box remember to find them later), fully remove the 3 nuts and wedge the cover upwards with something soft like a hammer handle. When you feel resistance you've topped out on the mainshaft nut, which can then be removed, and the casing drawn off the remaining 2 long studs. Put the casing aside, as it will be dismantled later.

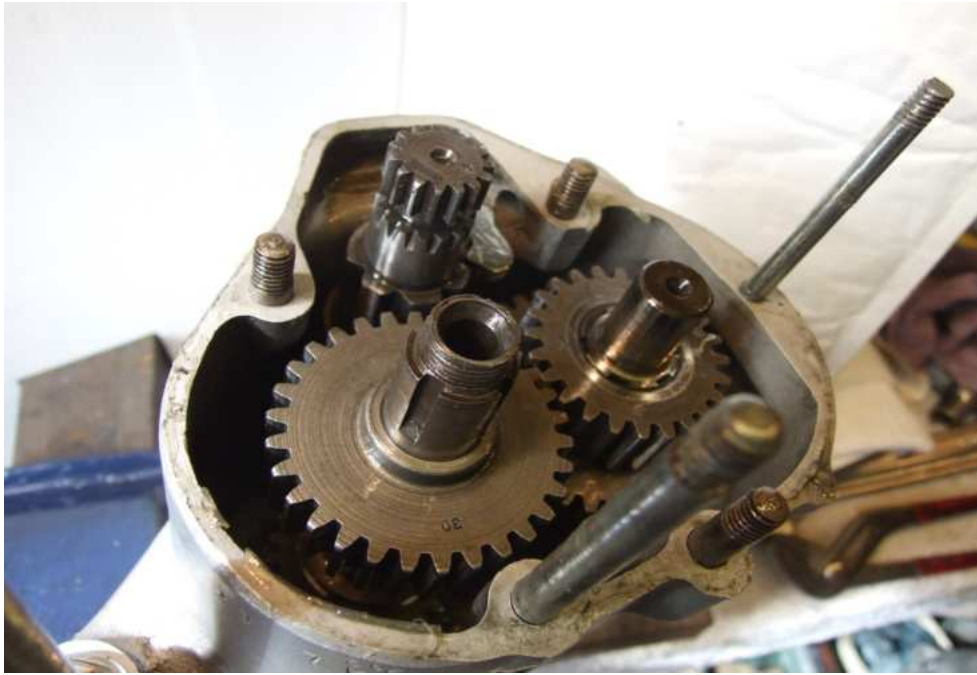
The gears can now be seen, with the larger mainshaft set to the left and layshaft gears to the right and selector shaft to the top in this photograph.

If you rotate the selector shaft a little either way you'll see the gear dogs lift & fall to engage/disengage gear sets. To the right of the selector shaft is the (silver) detent peg , operated by the spring that you earlier removed, which matches the various gear selector positions. It is held in place by a small nut and this should not be disturbed unless replacement is necessary.

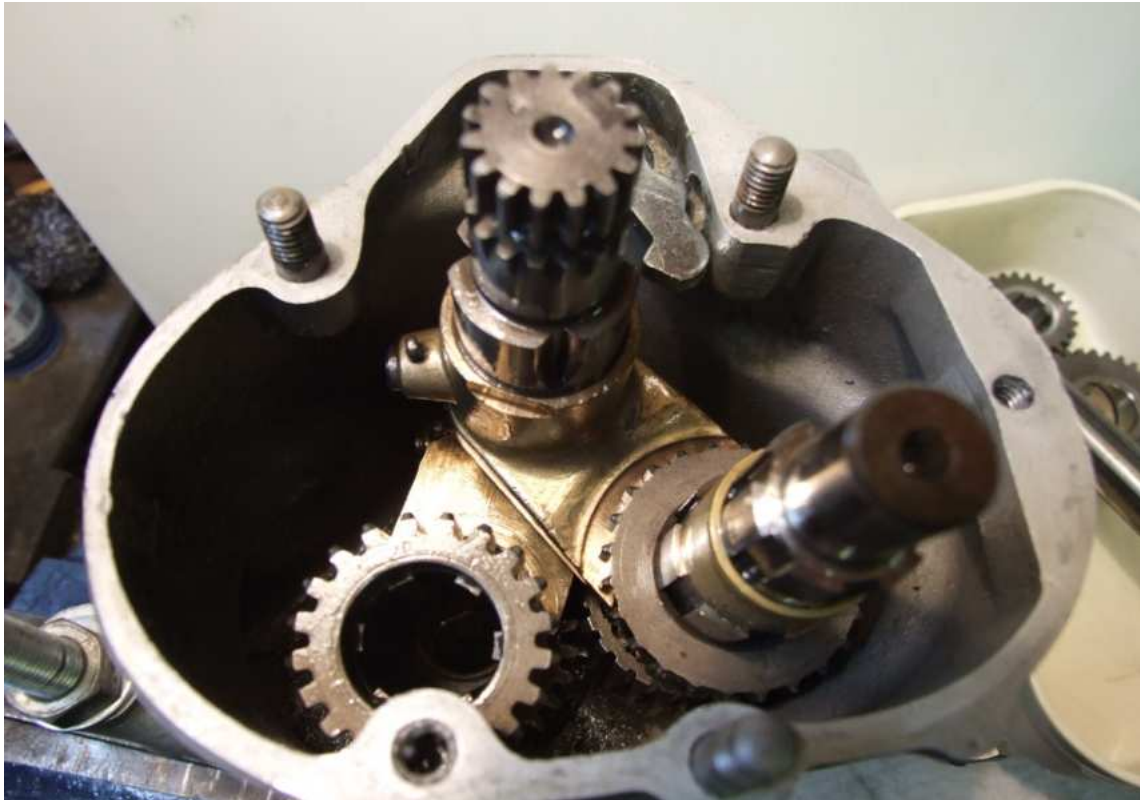
The gear cluster – this is how it goes back in on reassembly. It's simpler to do than it looks.

Remove the gears in turn until you reach the point where all of the loose ones are out of the gearbox, and the remainder are held in place by the selector forks. Remove the mainshaft from the bottom of the gearbox. Holding the cluster of gears, still attached to the selector forks, lift the whole group, including shafts, out of the gearbox shell.

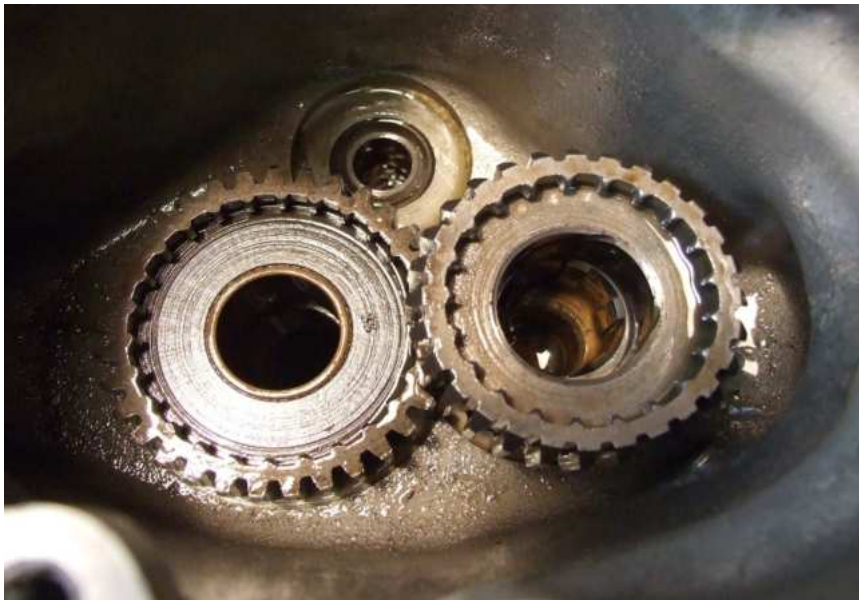
Still inside the gearbox is the large mainshaft drive gear to the left in picture and 2 loose layshaft gears to the right (a smaller one is out of sight here). Remove the layshaft pair first. The mainshaft gear has a sleeve which passes through the centre of the large mainshaft bearing located in the casing. Draw the gear upwards and recover the loose outside metal sleeve, which will either fall out or sit in the centre of the outer oil seal.

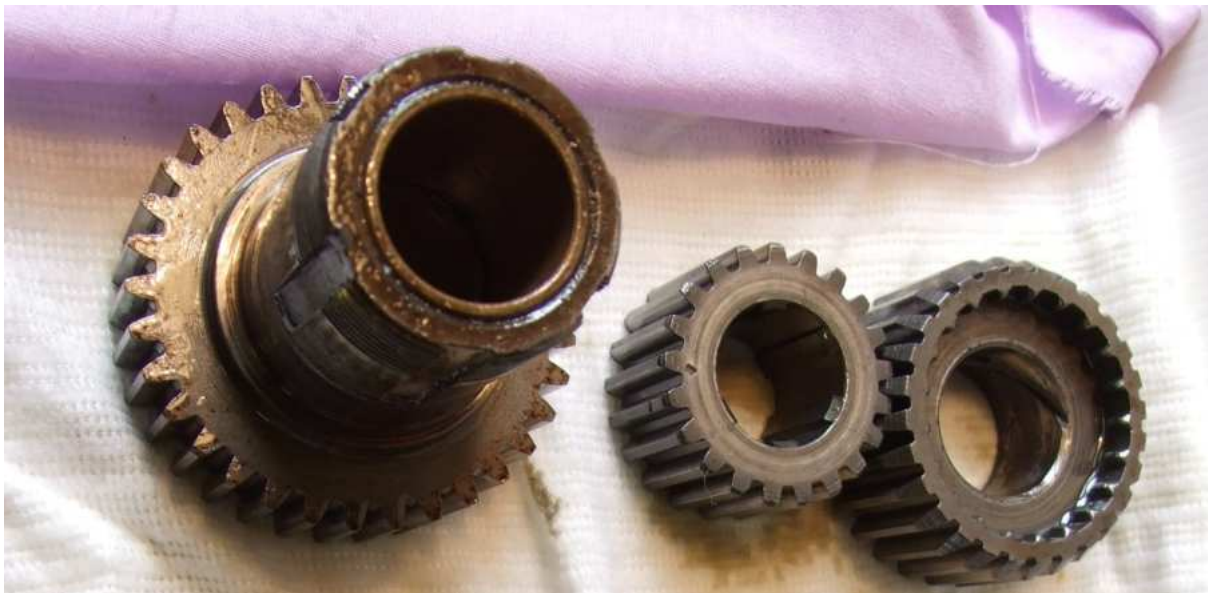
The same 2 gears removed below , mainshaft gear turned over to show splined drive sprocket sleeve plus 2 layshaft gears.

To find them on the diagram they appear (L-R) as 3080-34, 3135-34 and 3125-34 . Inside 3080-34 are the 2 larger Oilite bushes, 3087-31 x 2.

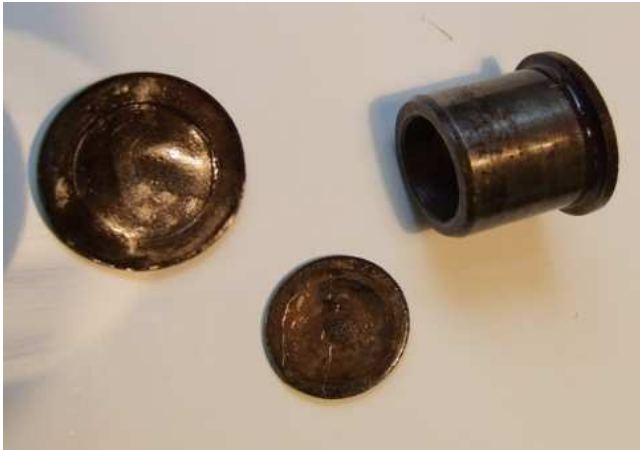
The selector shaft bush is hardened and should show little sign of wear, so unless it is suspect, then leave it where it is. This one was removed as it was slightly loose and moved back and forth, and will be refitted with Loctite. This steel bush is driven into the gearbox from outside for removal, and this can be done when the casing is heated to remove main bearing & Layshaft bush.

To remove the above selector bush or the layshaft Oilite bush you'll need to tap out, **from inside**, the metal caps that act as oil seals. Find a long drift (not screwdriver!!) that passes through the bushes from inside and lightly tap out the thin caps. No money was wasted by Burman on those. Also shown in picture the removed selector shaft bush. Top hat rim goes to the inside of the casing.

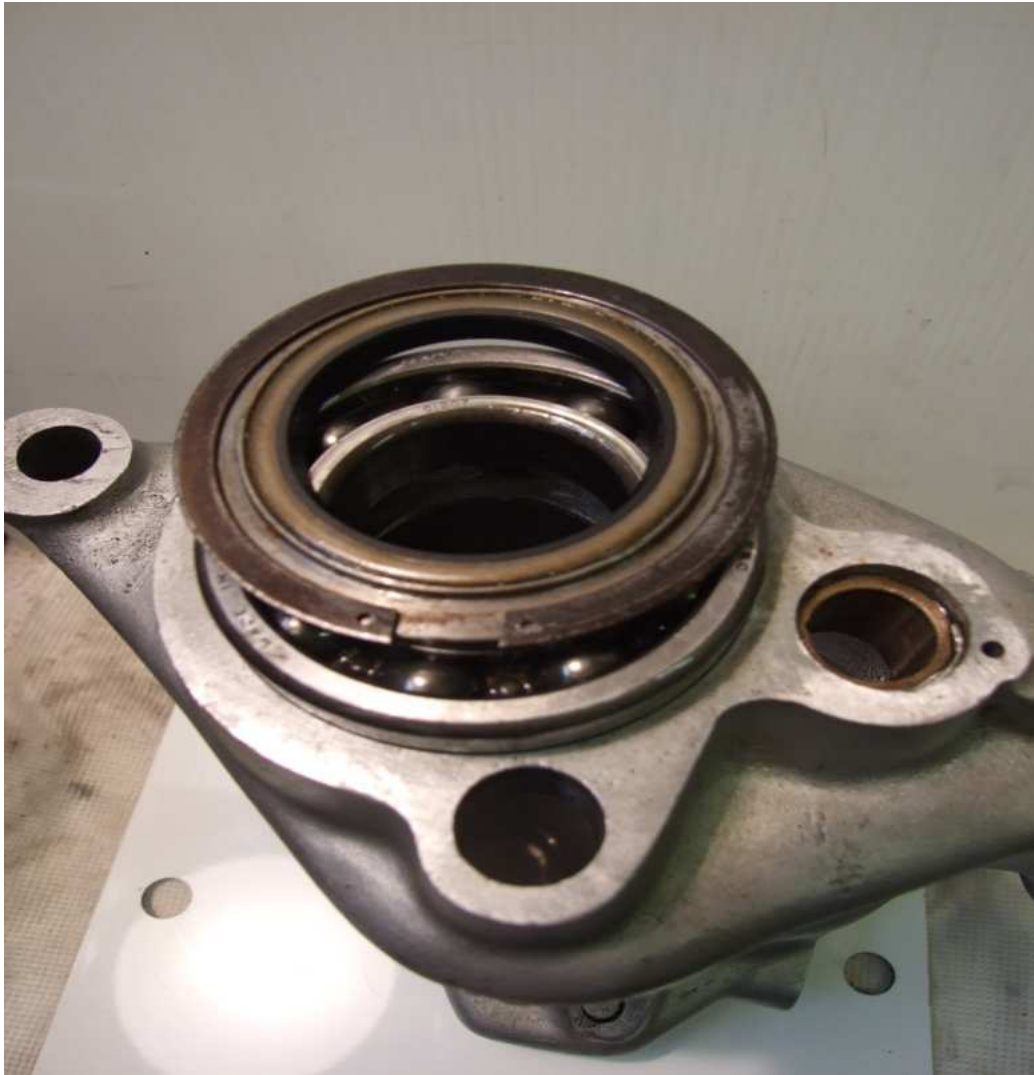
Removal of the bearing starts from outside of the gearbox, with removal of the large circlip and oil sealing ring. Push down hard on the circlip pliers and free the whole ring before trying to lift it out – avoid prising the circlip up with screwdrivers as the groove is narrow and damage inevitable to the groove and the circlip. The seal has a broad hardened steel ring and careful use of a broad screwdriver beneath this ring, avoiding catching the oil seal lip, will raise the ring. Work around the ring, rather than levering from one point.

Once the (huge!) bearing has been exposed it is wise to thoroughly clean out the whole casing to remove oil residues, before heating it to as much as 270C+ in your oven. You may get away with lower temp., but not if Loctite has been used. The bearing may well fall out in the oven, so make sure that the casing is supported so that this can happen. If the bearing doesn't fall out, then you may well do so with your wife for doing this in her kitchen! Ovens self-clean at these temperatures, so smoke alarms will alert the neighbours and they'll tell your wife what you have done.

If the bearing doesn't fall out of its own accord support the very hot casing on wooden blocks and tap the bearing evenly from inside the casing, either with a long, large diameter drift, or tapping at the 4 points of the compass in turn on the bearing centre with a brass drift or similar.

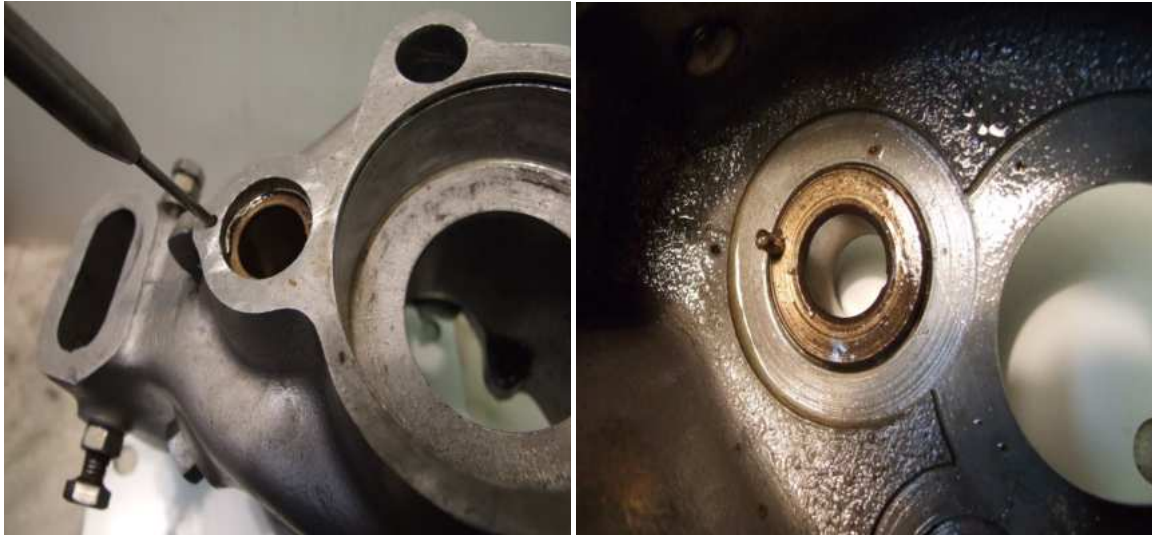
If you are well prepared then this can be done at the same time as the main bearing, with the case hot. From the outside of the gearbox you will see a small hole near the tin plug for the layshaft. Use a flat ended pin punch to drive the metal locating pin out of the casing and through the Oilite bearing. Retain this pin.

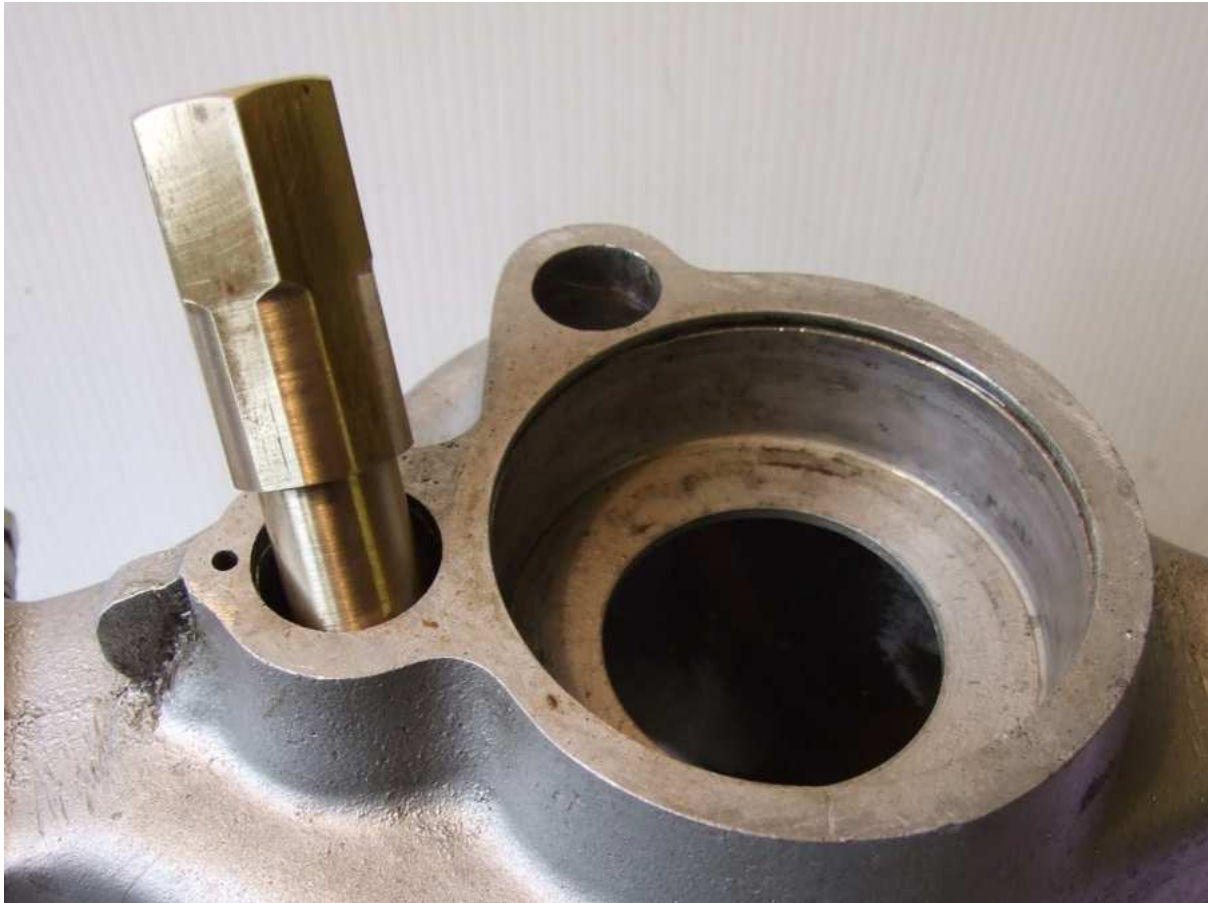
Working from outside, using a drift (ideally stepped, dimensions as shown) push/tap the Oilite bush into the hot casing until it drops out. The same drift is used in replacement.

Oilite is quite weak and porous, and damages/distorts easily – it's the metal equivalent of Weetabix. You won't be able to re-use this removed bearing, so be certain that it does need replacing before knocking it out. Keep the old bush as a reference as the POC ones need reducing in length. Any replaced Oilites will need reaming to size– it's not a difficult nor expensive job and shouldn't put you off replacing them- all shown in the **Rebuild** section.

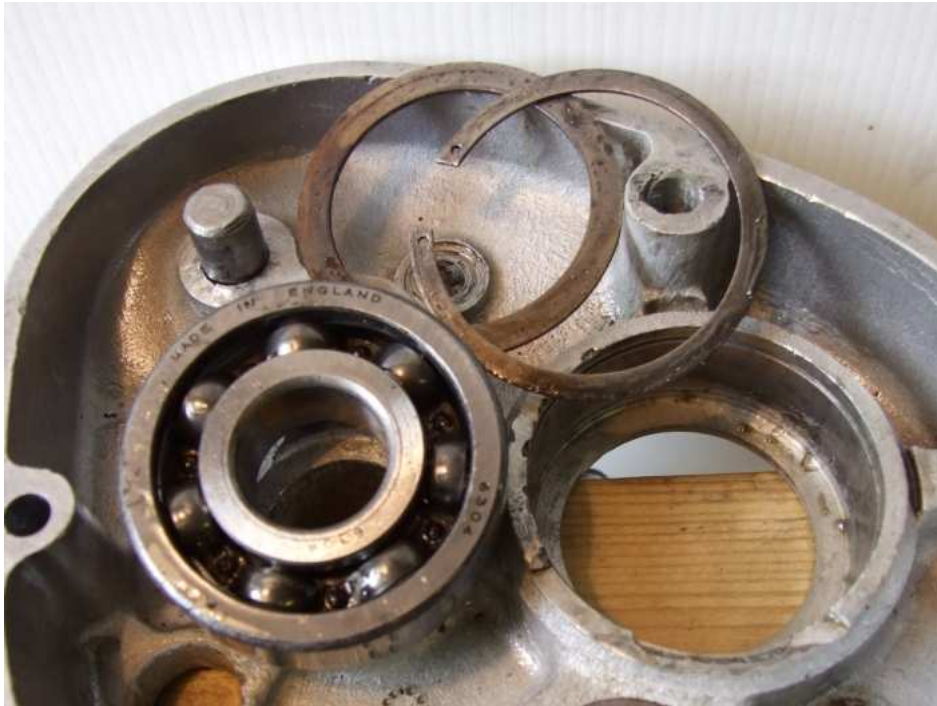
The same technique & tools are used to remove the identical Oilite bush in the gearbox main casing, so this job can be done at the same time. You must heat the centre casing to remove both the Oilite bush and the ball bearing race, fully supporting the casting as you do this. Get your wooden blocks, large sockets and any other supports ready and in place, before starting to heat the casing. Anything other than a light tap to shift the bearing race means that the casing isn't hot enough and/or Loctite has been used, so more heat required.

If the kickstart stop pin (shown 11 o'clock above bearing race here) is bent / damaged /loose this can also be tapped out from behind.
