## A beginners guide to Burman II – by Joe Rayner

### Part 2

#### Burman Gearbox Wear and Tear

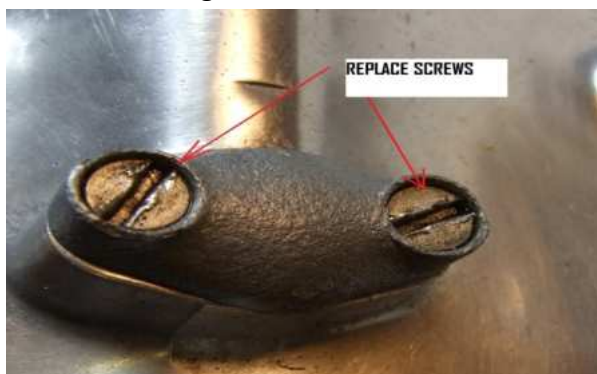
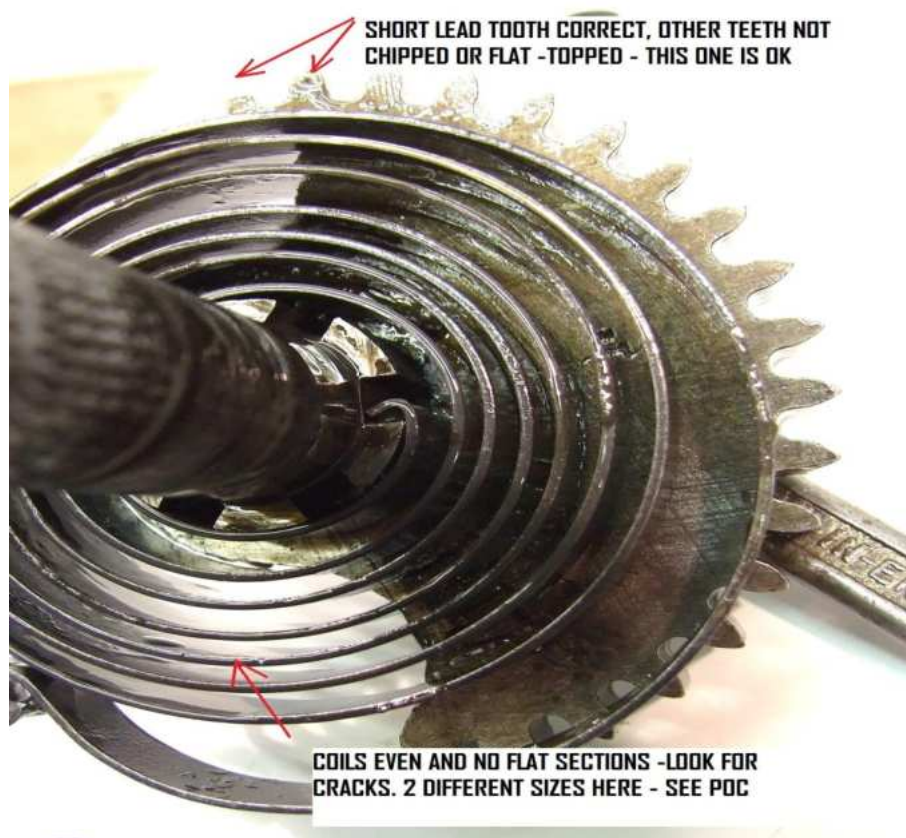
Check the outer casing for damage, cracks, oil leaks, shaft bush wear, thread damage. The part is now over 50 years old and will not be perfect. Cosmetics may polish out, cracks can be professionally repaired, thread inserts fitted, and better second-hand covers may come up. POC have a limited number of related spares, but Draganfly, in Bungay, Suffolk also carry some parts for Burman, and I believe that the Vincent Owners Club carries spares as the Vincent Comet was fitted with a similar Burman gearbox.

Kickstart springs are available from POC (wide & narrow), along with new studs, nuts and filler cap. The clutch adjuster cover screws are often victims of the dodgy screwdriver – Whitworth threads here, but widely available. Both the kickstart and gear selector shaft bushes are hardened, which means that the shafts can also become worn. This may lead to poor gear selection and oil leaks. If the wear isn't having an effect on the operation of either lever then it might be considered 'cosmetic', or a case of searching for something better!

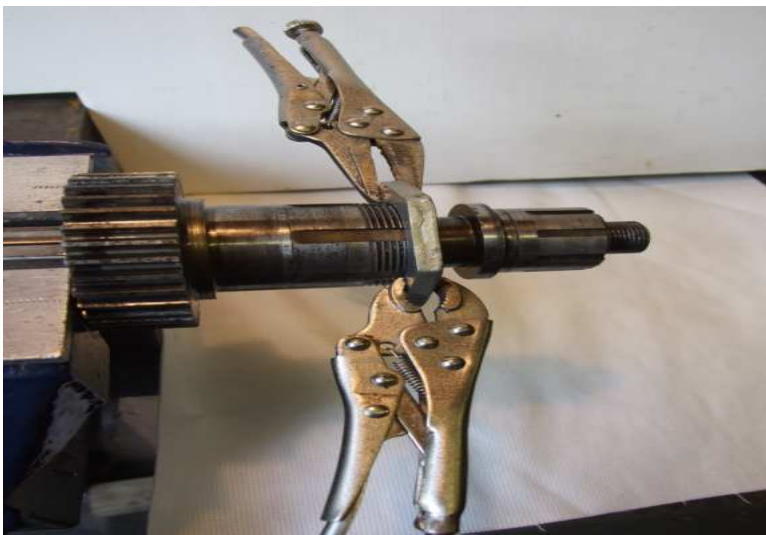
A check to see the impact of wear in these bushes on clutch 'wobble' is worth doing, just to convince you that changing the bushes is worthwhile. Set the mainshaft & drive gear onto the shaft and re-fit the large drive nut, as shown, with a couple of small Mole Grips, or a straight edge across the nut face.

Rock the drive gear on its bearing and the movement will be similar to the rock that is found at the clutch sprocket teeth. I set up a dial gauge, and, on a 'moderately' worn bearing/shaft, there was 20 thou+ movement at the same diameter as the clutch –
